**Village of Duchess**  
**Infrastructure Master Plan**  
(1447-001-01)

October 2018

**Re: Village of Duchess – Infrastructure Master Plan**

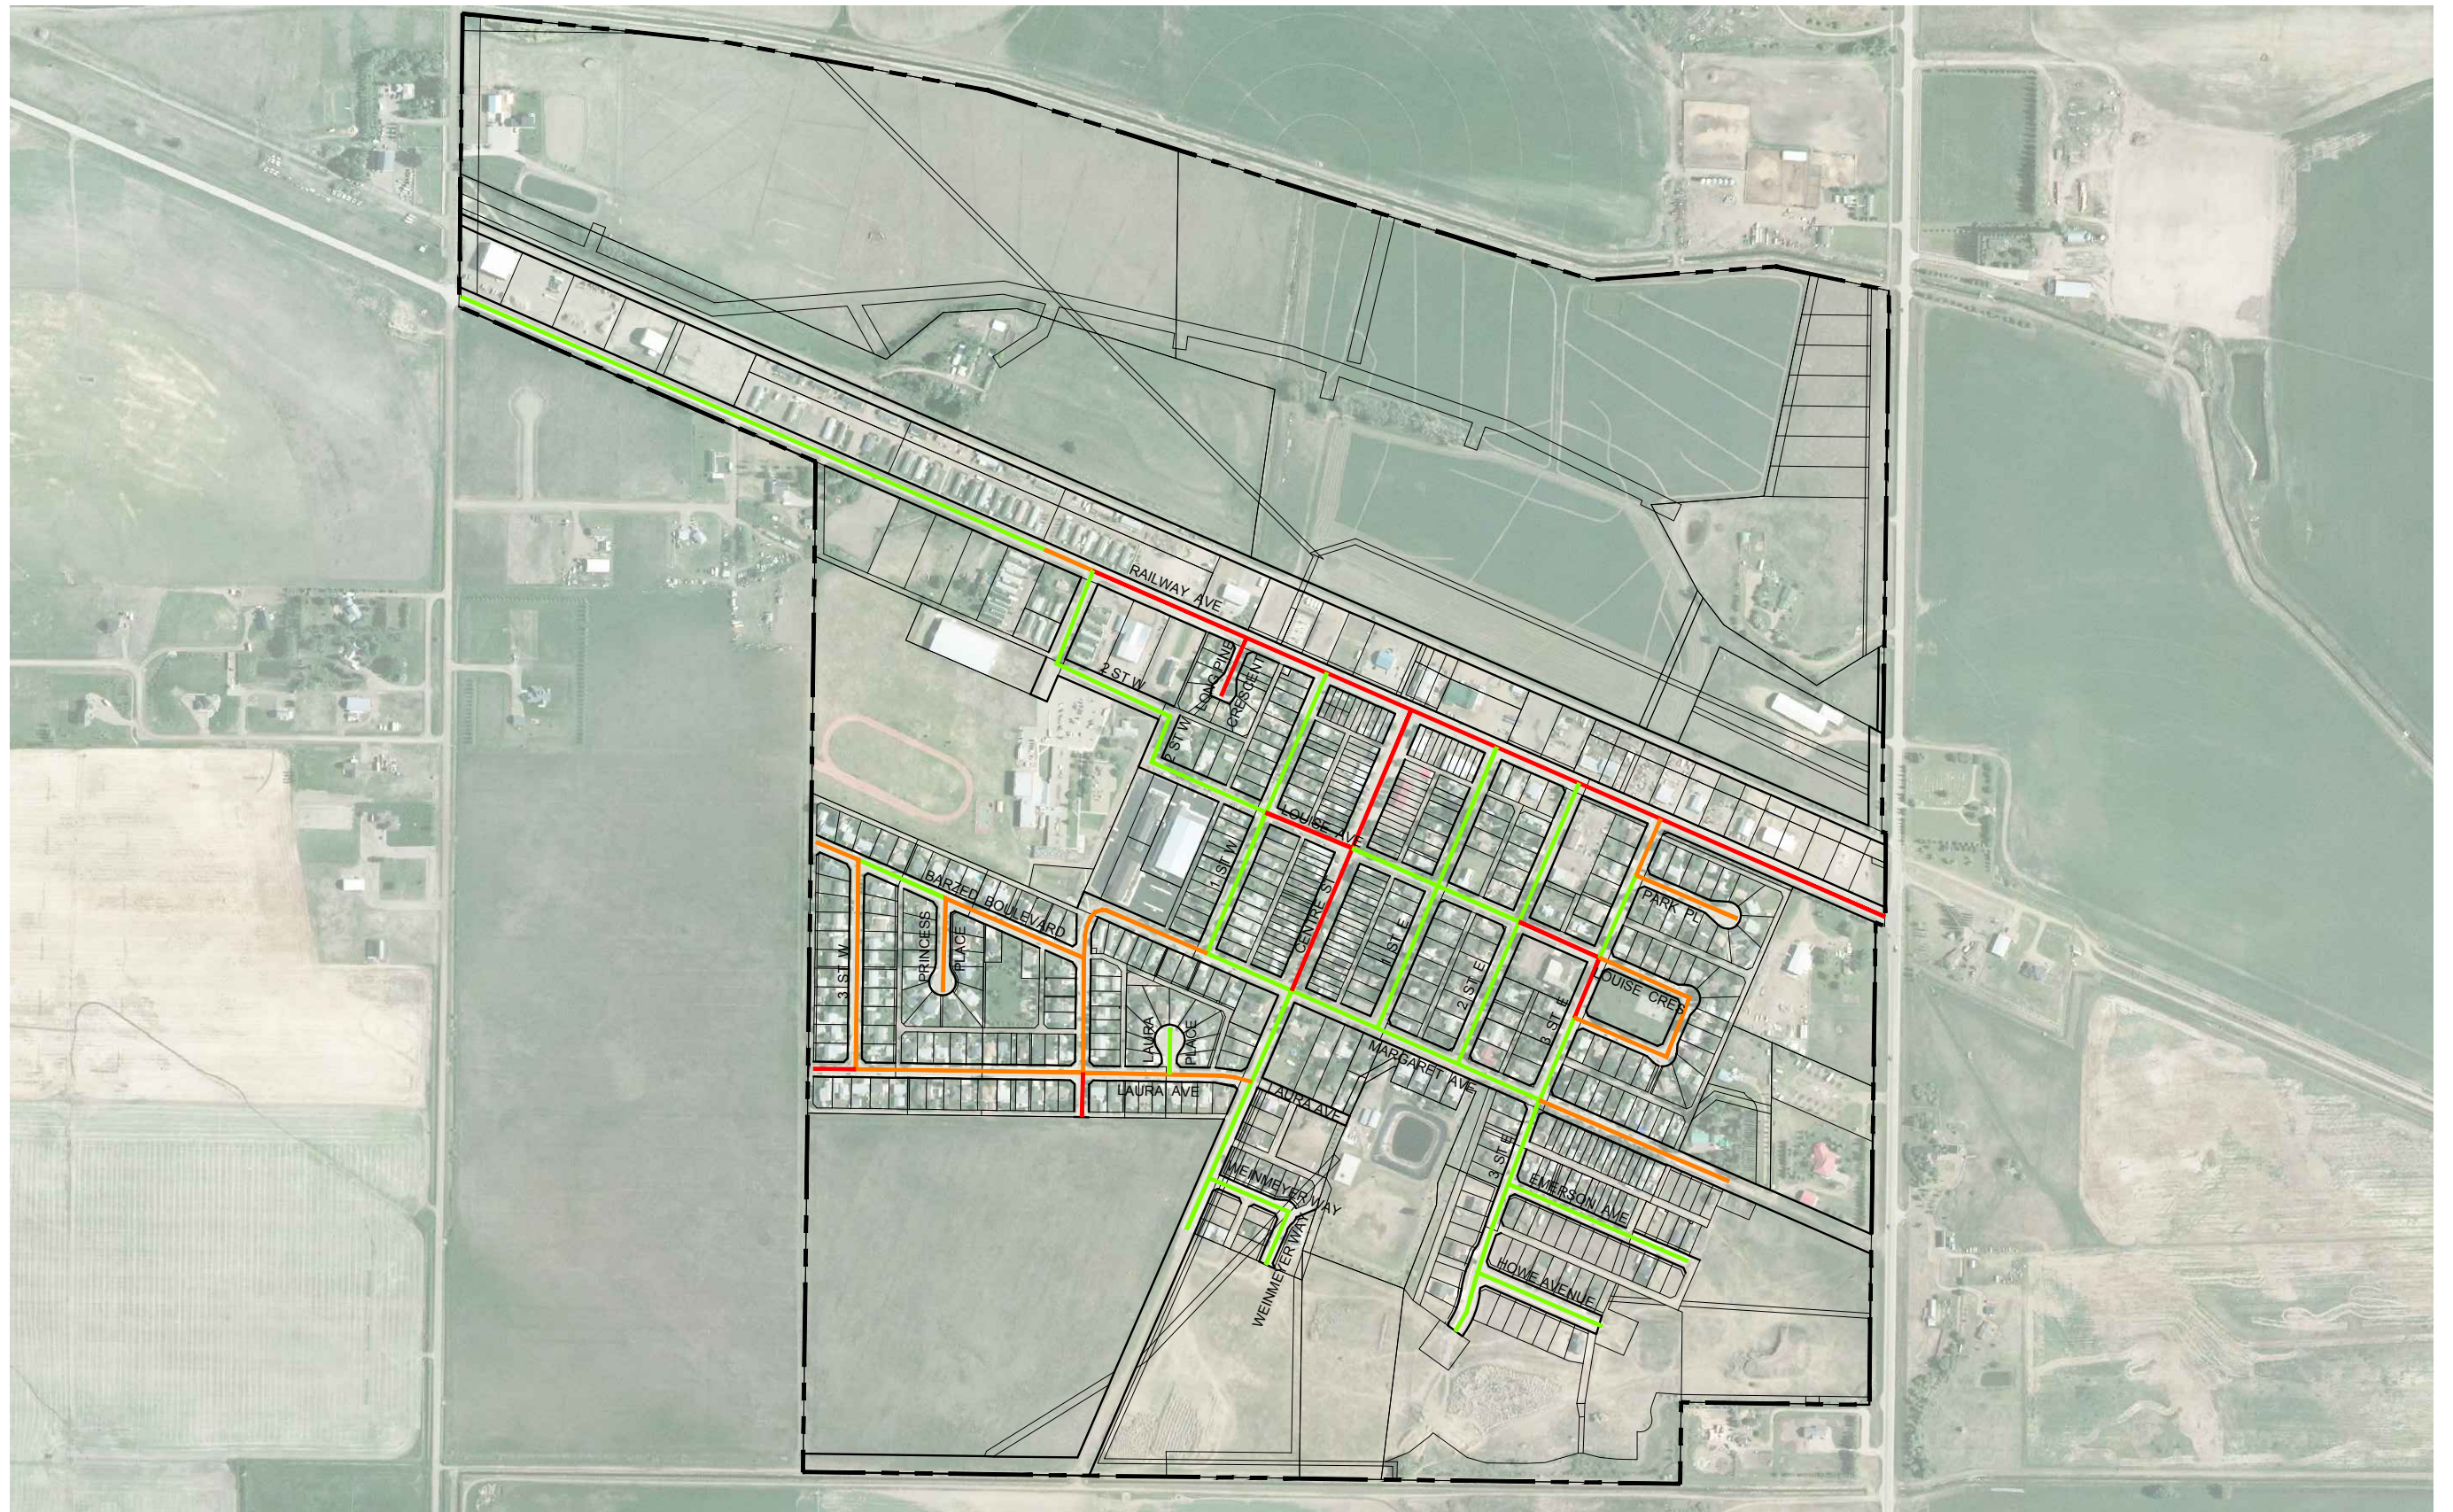
VILLAGE OF DUCHESS  
INFRASTRUCTURE MASTER PLAN  
ROAD CONDITION OVERVIEW

The road evaluation revealed that several roads require minor and major repair work. Much of the repairs identified in the evaluation may be attributed to the age of the existing roadway structure as well as relatively high ground water conditions and storm water ponding. The Road Evaluation Spreadsheet in Appendix A provides details of the upgrades identified for each roadway.

Dutchess has approximately 82,800 square metres of road surface, all of which are hot mix asphalt roads. The evaluation identified approximately 24,100 square metres (29%) of hot mix asphalt roads that require improvement in the short term. The improvements will extend the life of the road and prevent the road from progressing to a failed condition in the short term. There are 20,300 square metres (25%) of hot mix asphalt roads that will require improvements in mid term infrastructure plans. The evaluation also identified 38,400 square metres (46%) of hot mix asphalt roads that will require improvements in long term infrastructure plans. The vast majority of the repairs are overlays. The overlays will address the cracking, oxidization and ravelled surface exhibited by the aging pavement. A regular maintenance program involving crack seal treatments and filling potholes will extend the life of asphalt road surfaces.

Refer to Figure 3.1 for an overview of the road system and the overall condition of the roads.

It is recommended that the Village utilize the condition rating system identified to prioritize and implement the roadway repairs and replacement work. Generally, those components with a condition rating of “poor” should be incorporated into the short term maintenance work. Components with a condition rating of “fair” should be incorporated into the mid and long term road infrastructure repair and replacement strategy. Components with a condition rating of “good” should be re-evaluated bi-annually with their condition rating and priority updated as required. Short term is defined as work to be performed within 5 years, midterm is work to be performed in 5 to 10 years, and long term has been defined as work to be performed in 10 years and beyond.

It is recommended that the Village develop and implement an asphalt overlay program for the mid and long term road infrastructure management strategy. Due to the age of some of the paved roads, it would be prudent to undertake structural and surface pavement improvements while the roads are still

It is recommended that the Village continue the current annual maintenance program and ensure it includes crack-sealing and localized asphalt repair (pothole repair). This will limit damage to the road structure by minimizing saturation of the road structure and subgrade.

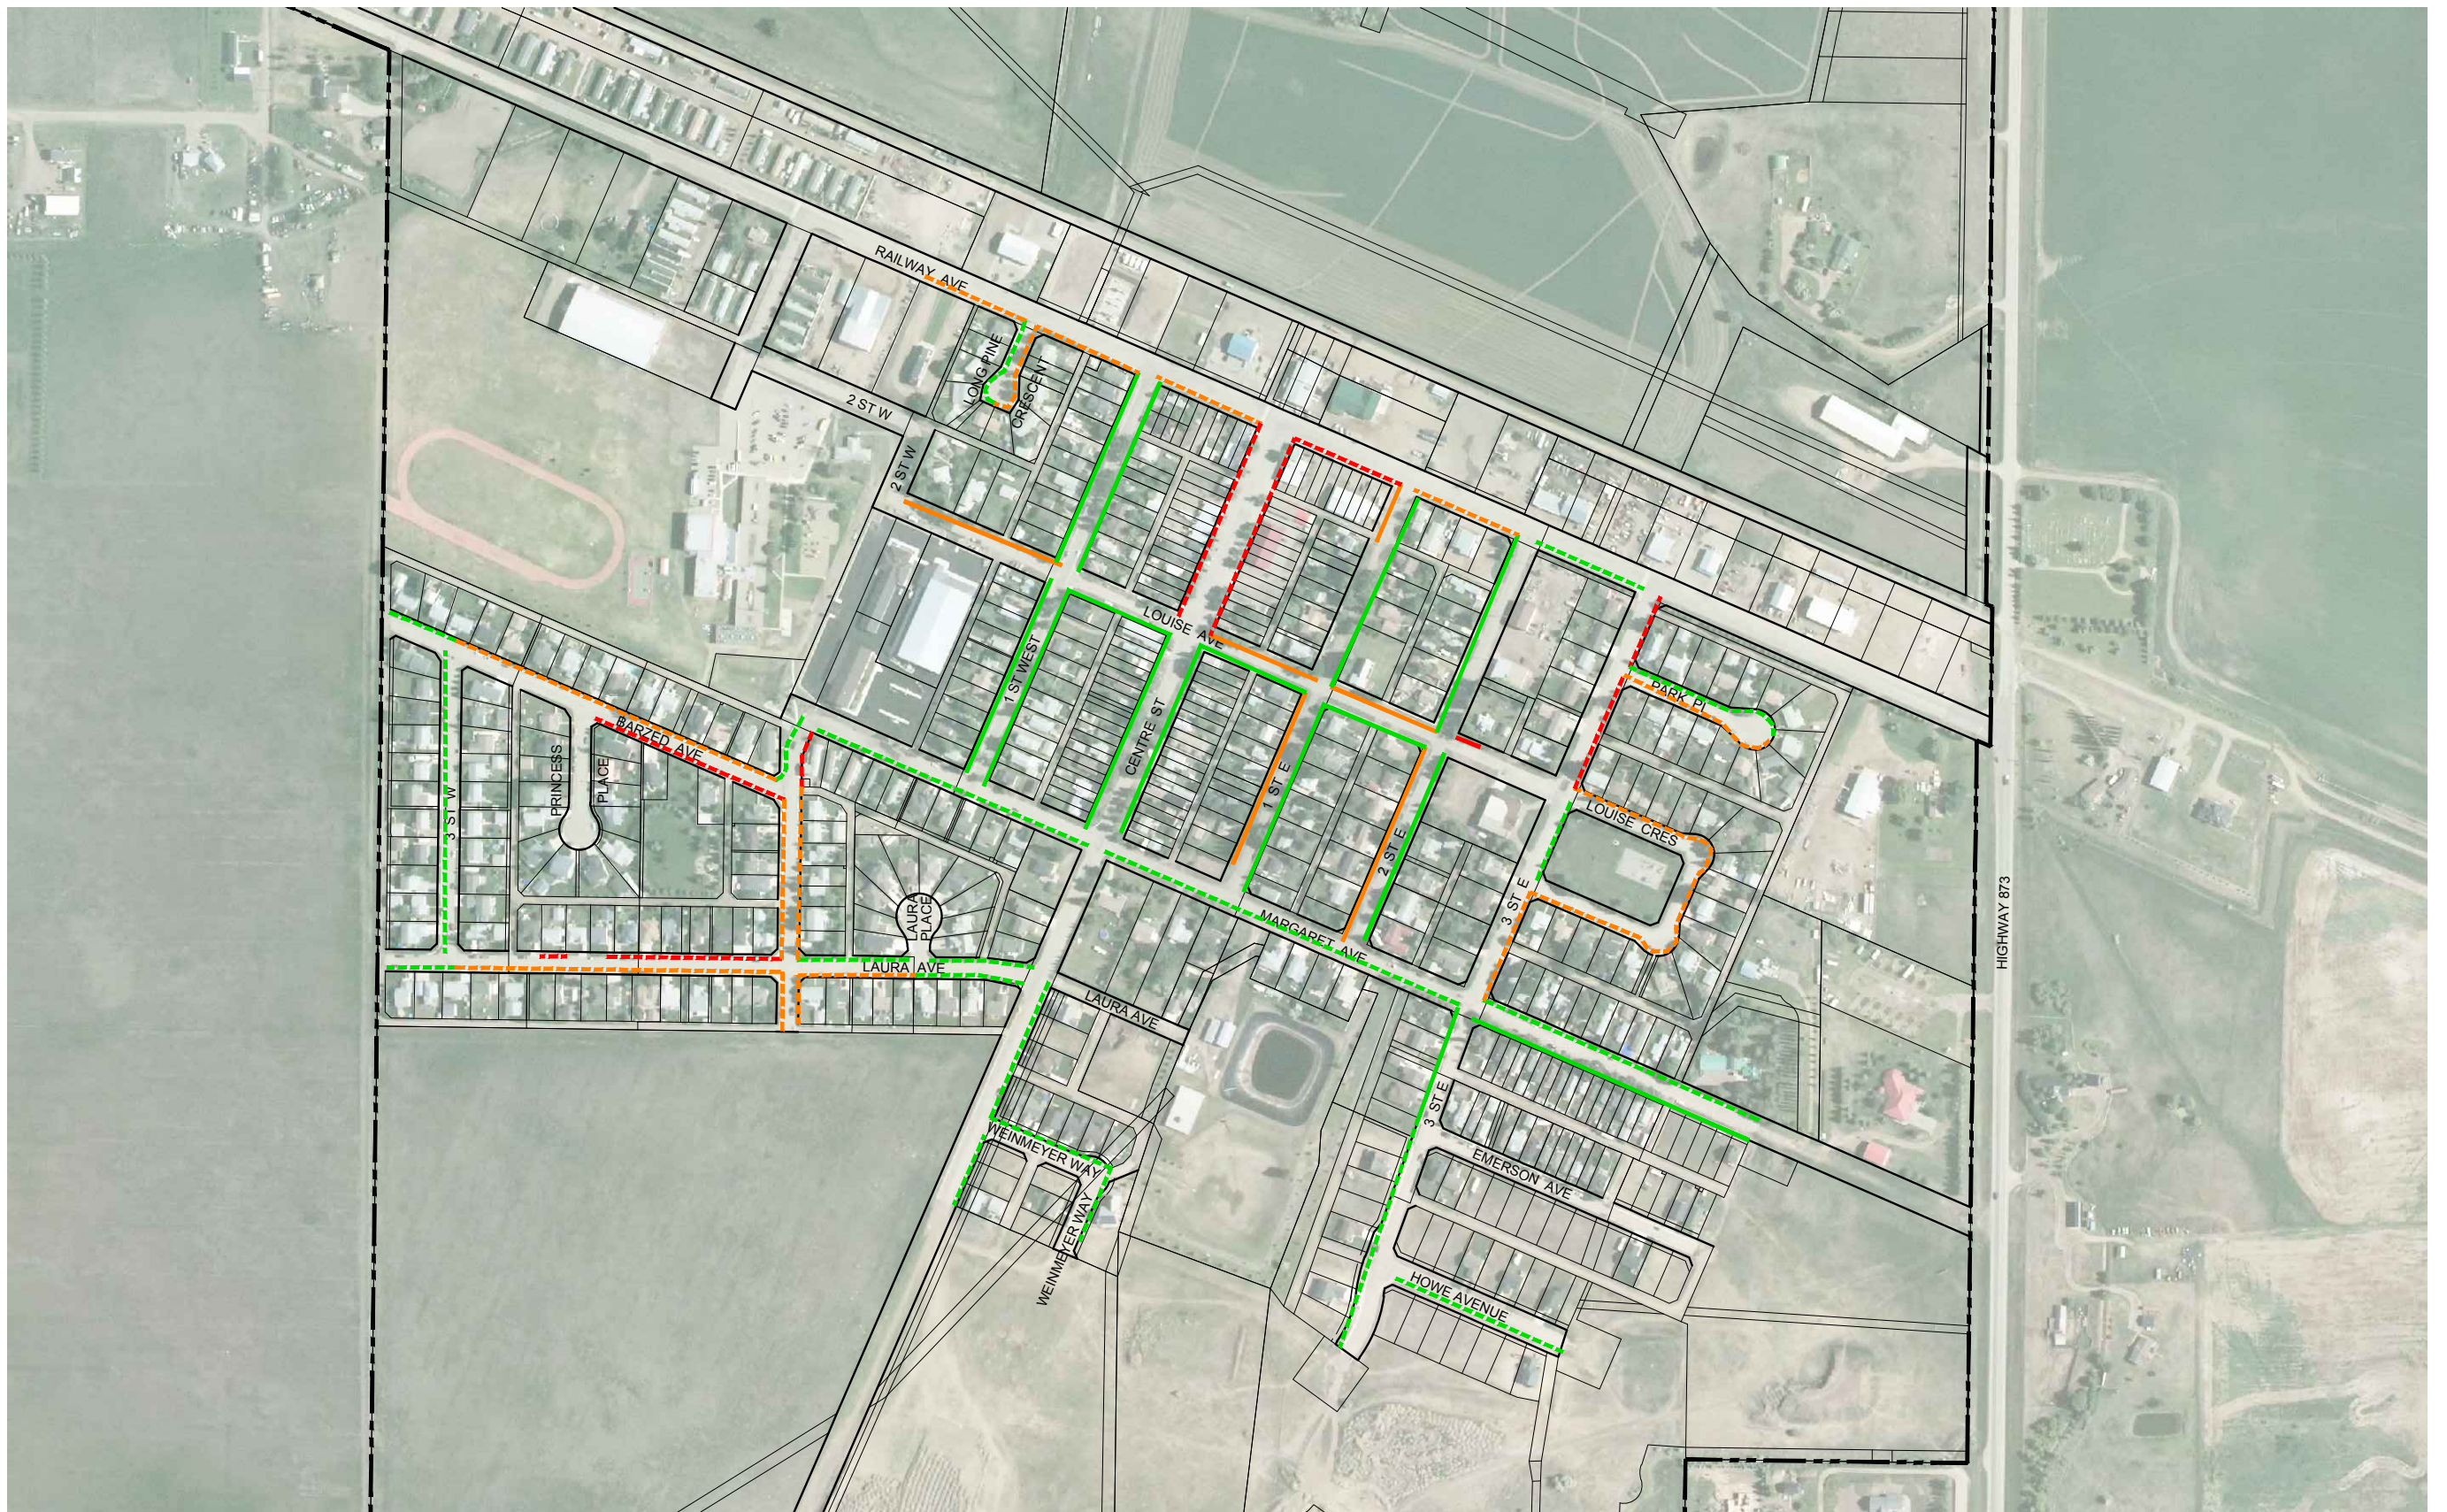
<b>VILLAGE OF DUCHESS</b> <b>INFRASTRUCTURE MASTER PLAN</b> <b>SIDEWALK CONDITION OVERVIEW</b>			
		SCALE: 1:5000	DATE: OCTOBER 2018
		JOB: 1447-001-01	FIGURE: 3.2

Dutchess has approximately 3,500 square meters of concrete separate sidewalk, of which 75% have a “good” condition rating, and will not require repairs in the short to mid-term. There are 24% of the separate sidewalks with a “fair” rating, which may exhibit noticeable signs of deterioration, minor vertical and/or horizontal displacement, exposed surface, cracked surface and/or minor distortion. The remaining 1% of the separate sidewalks were evaluated in “poor” condition where there may be a missing section of sidewalk, a tripping hazard and/or severely deteriorated structure.

Dutchess has approximately 6,600 square meters of concrete monolithic sidewalk, of which 46% have a “good” condition rating, and will not require repairs in the short to mid-term. There are 32% of the monolithic sidewalks with a “fair” rating, which may exhibit noticeable signs of deterioration, minor vertical and/or horizontal displacement, exposed surface, cracked surface and/or minor distortion. The remaining 22% of the monolithic sidewalks were evaluated in “poor” condition where there may be a missing section of sidewalk, a tripping hazard and/or severely deteriorated structure.

Refer to Figure 3.2 for an illustration of the overall condition of the concrete sidewalks. Also, refer to the Road Component Evaluation spreadsheet in Appendix A for more details.

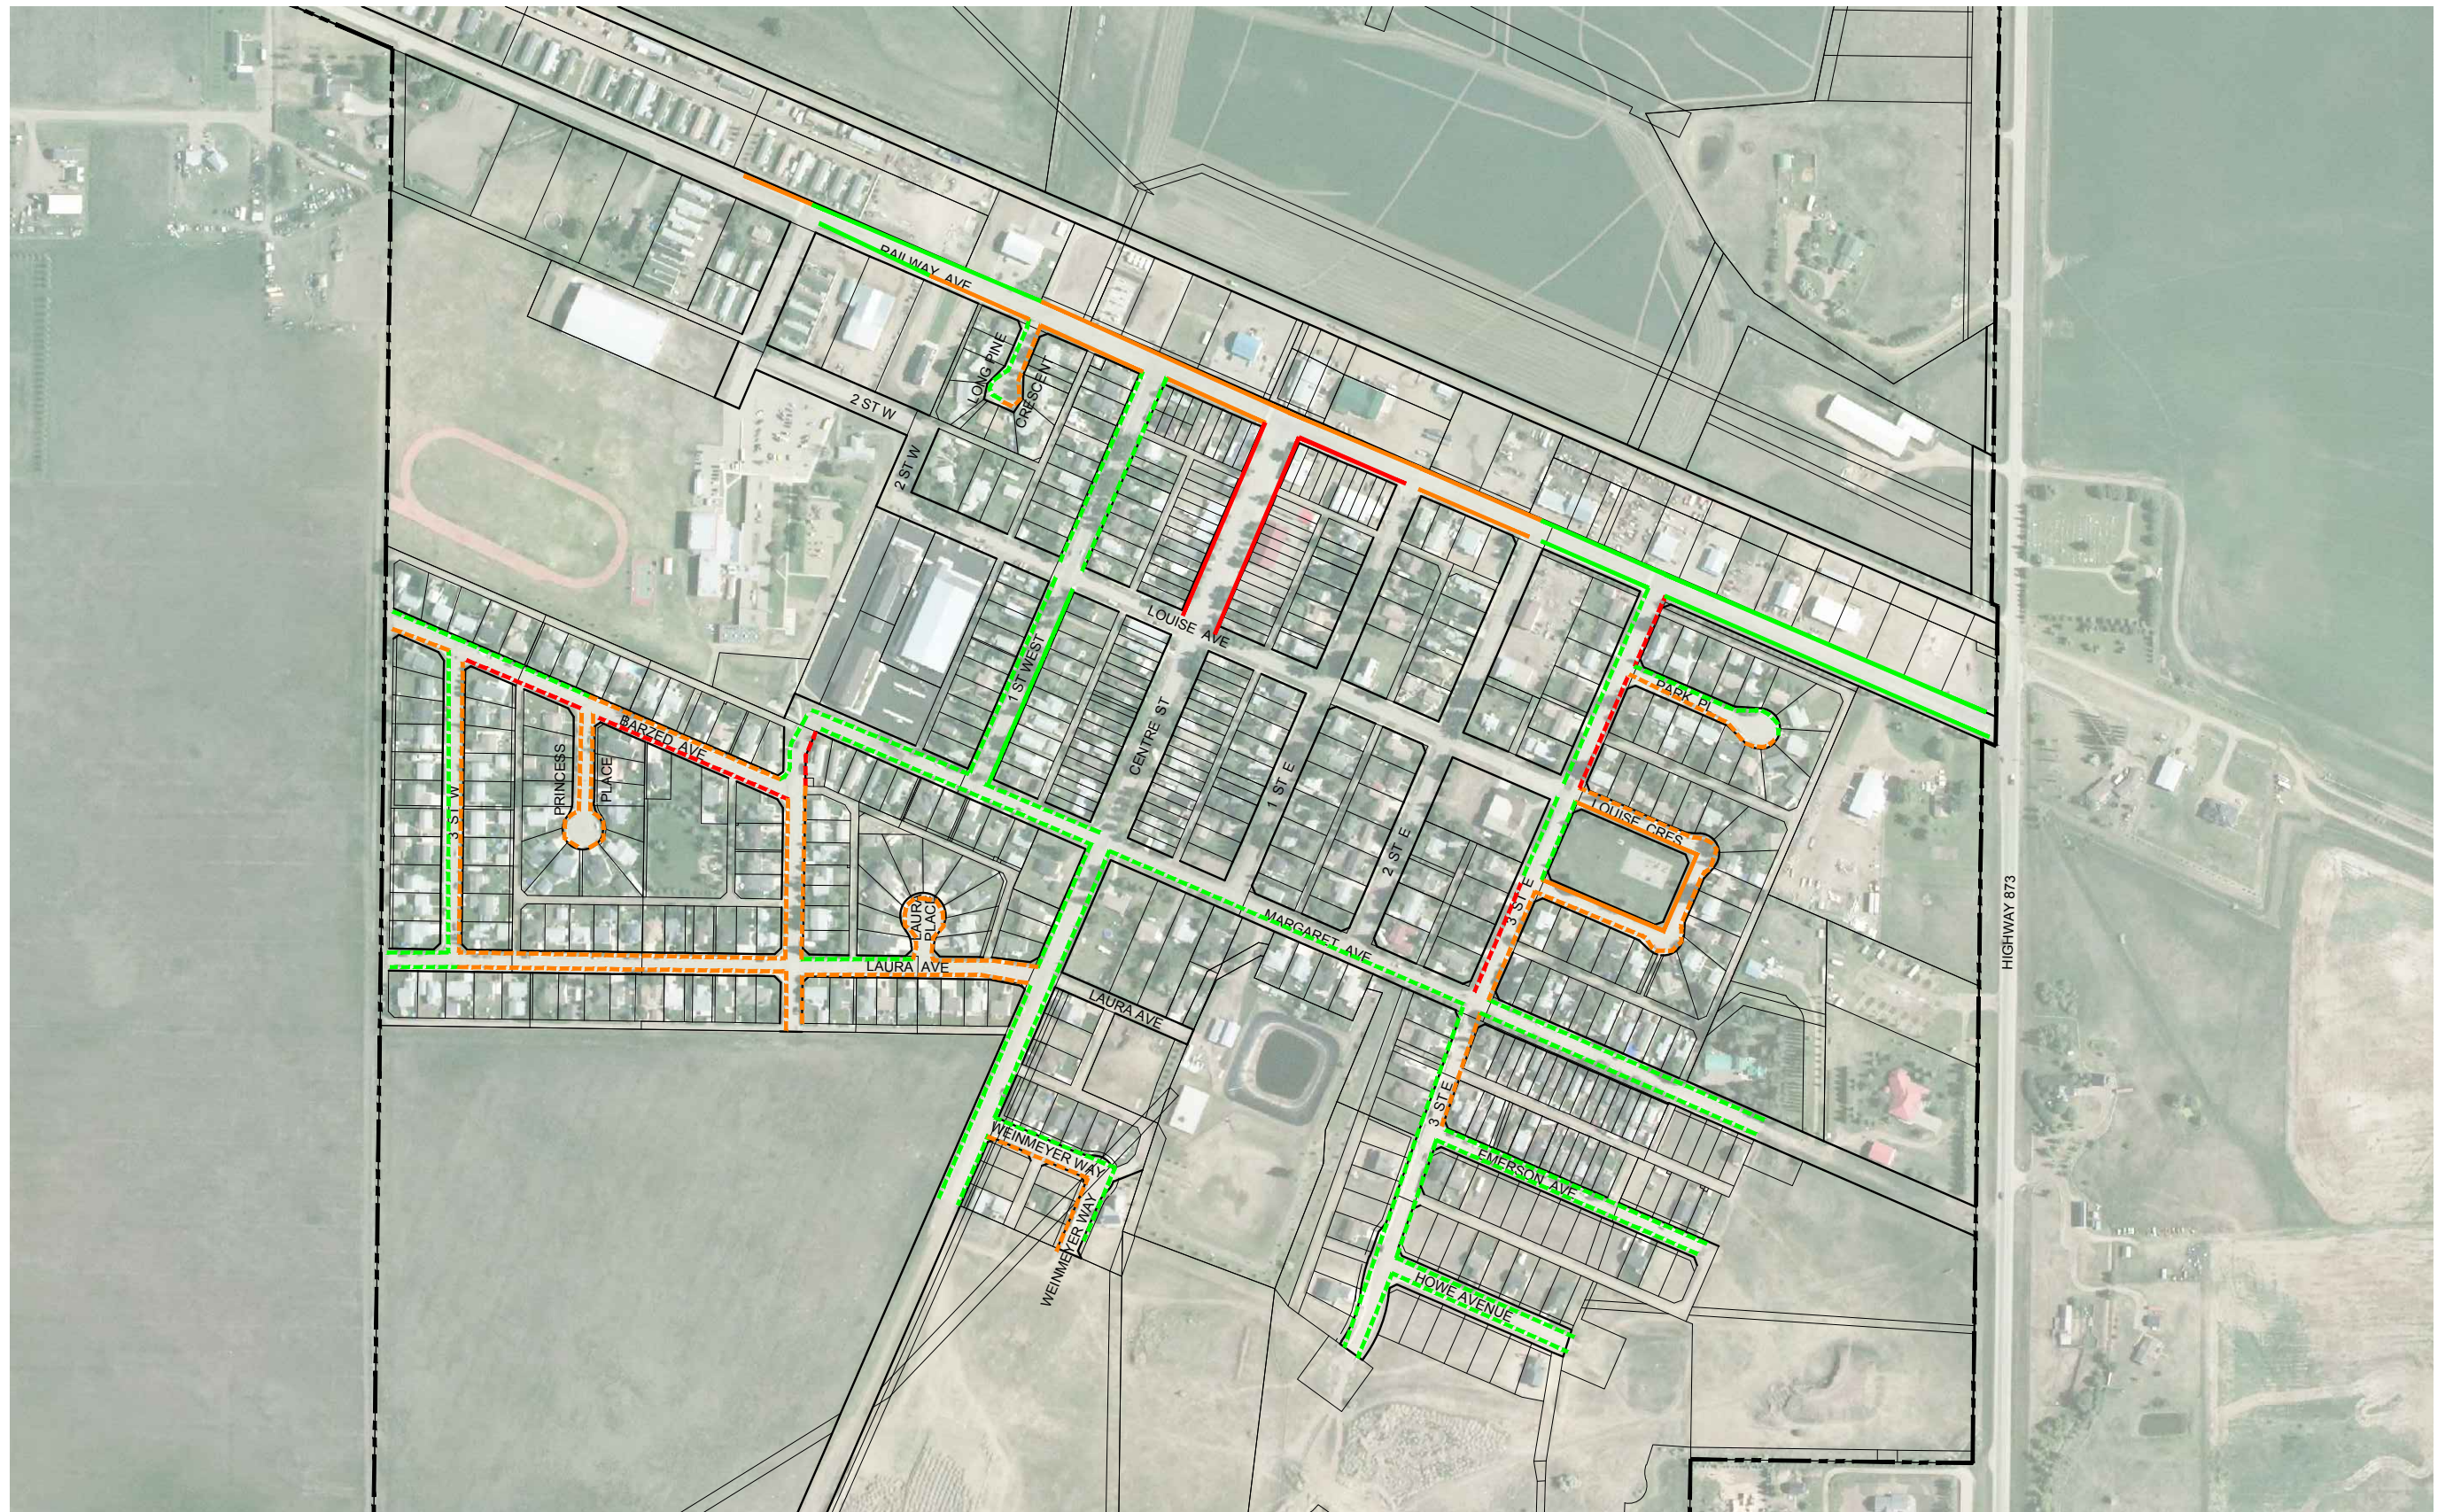
VILLAGE OF DUCHESS  
INFRASTRUCTURE MASTER PLAN  
CURB AND GUTTER CONDITION OVERVIEW

Dutchess has approximately 5,400 lineal metres of concrete curb and gutter throughout the Village. 65% of the curb and gutter is rated as “good”, with little or no signs of deterioration. 32% of the curb and gutter is rated as “fair”. Curb and gutter with a condition rating of “fair” indicates the component is still functioning in the roadway system, however is showing noticeable signs of deterioration requiring repairs in the medium or long term. The remaining 3% is rated as “poor”. A condition rating of “poor” indicates a high level of cracking, spalling, or displacement requiring repairs in the short term.

Dutchess has approximately 275 lineal metres of concrete swale throughout the Village. 53% of the concrete swale is rated as “good”, with little or no signs of deterioration. 47% of the concrete swale is rated as “fair”. Concrete swale with a condition rating of “fair” indicates the component is still functioning in the roadway system; however is showing noticeable signs of deterioration requiring repairs in the medium or long term. 0% is rated as “poor”. A condition rating of “poor” indicates a high level of cracking, spalling, or displacement requiring repairs in the short term.

Refer to Figure 3.3 for an illustration of the overall condition of the concrete curb and gutter. Also, refer to the Road Component Evaluation spreadsheet in Appendix A for more details.

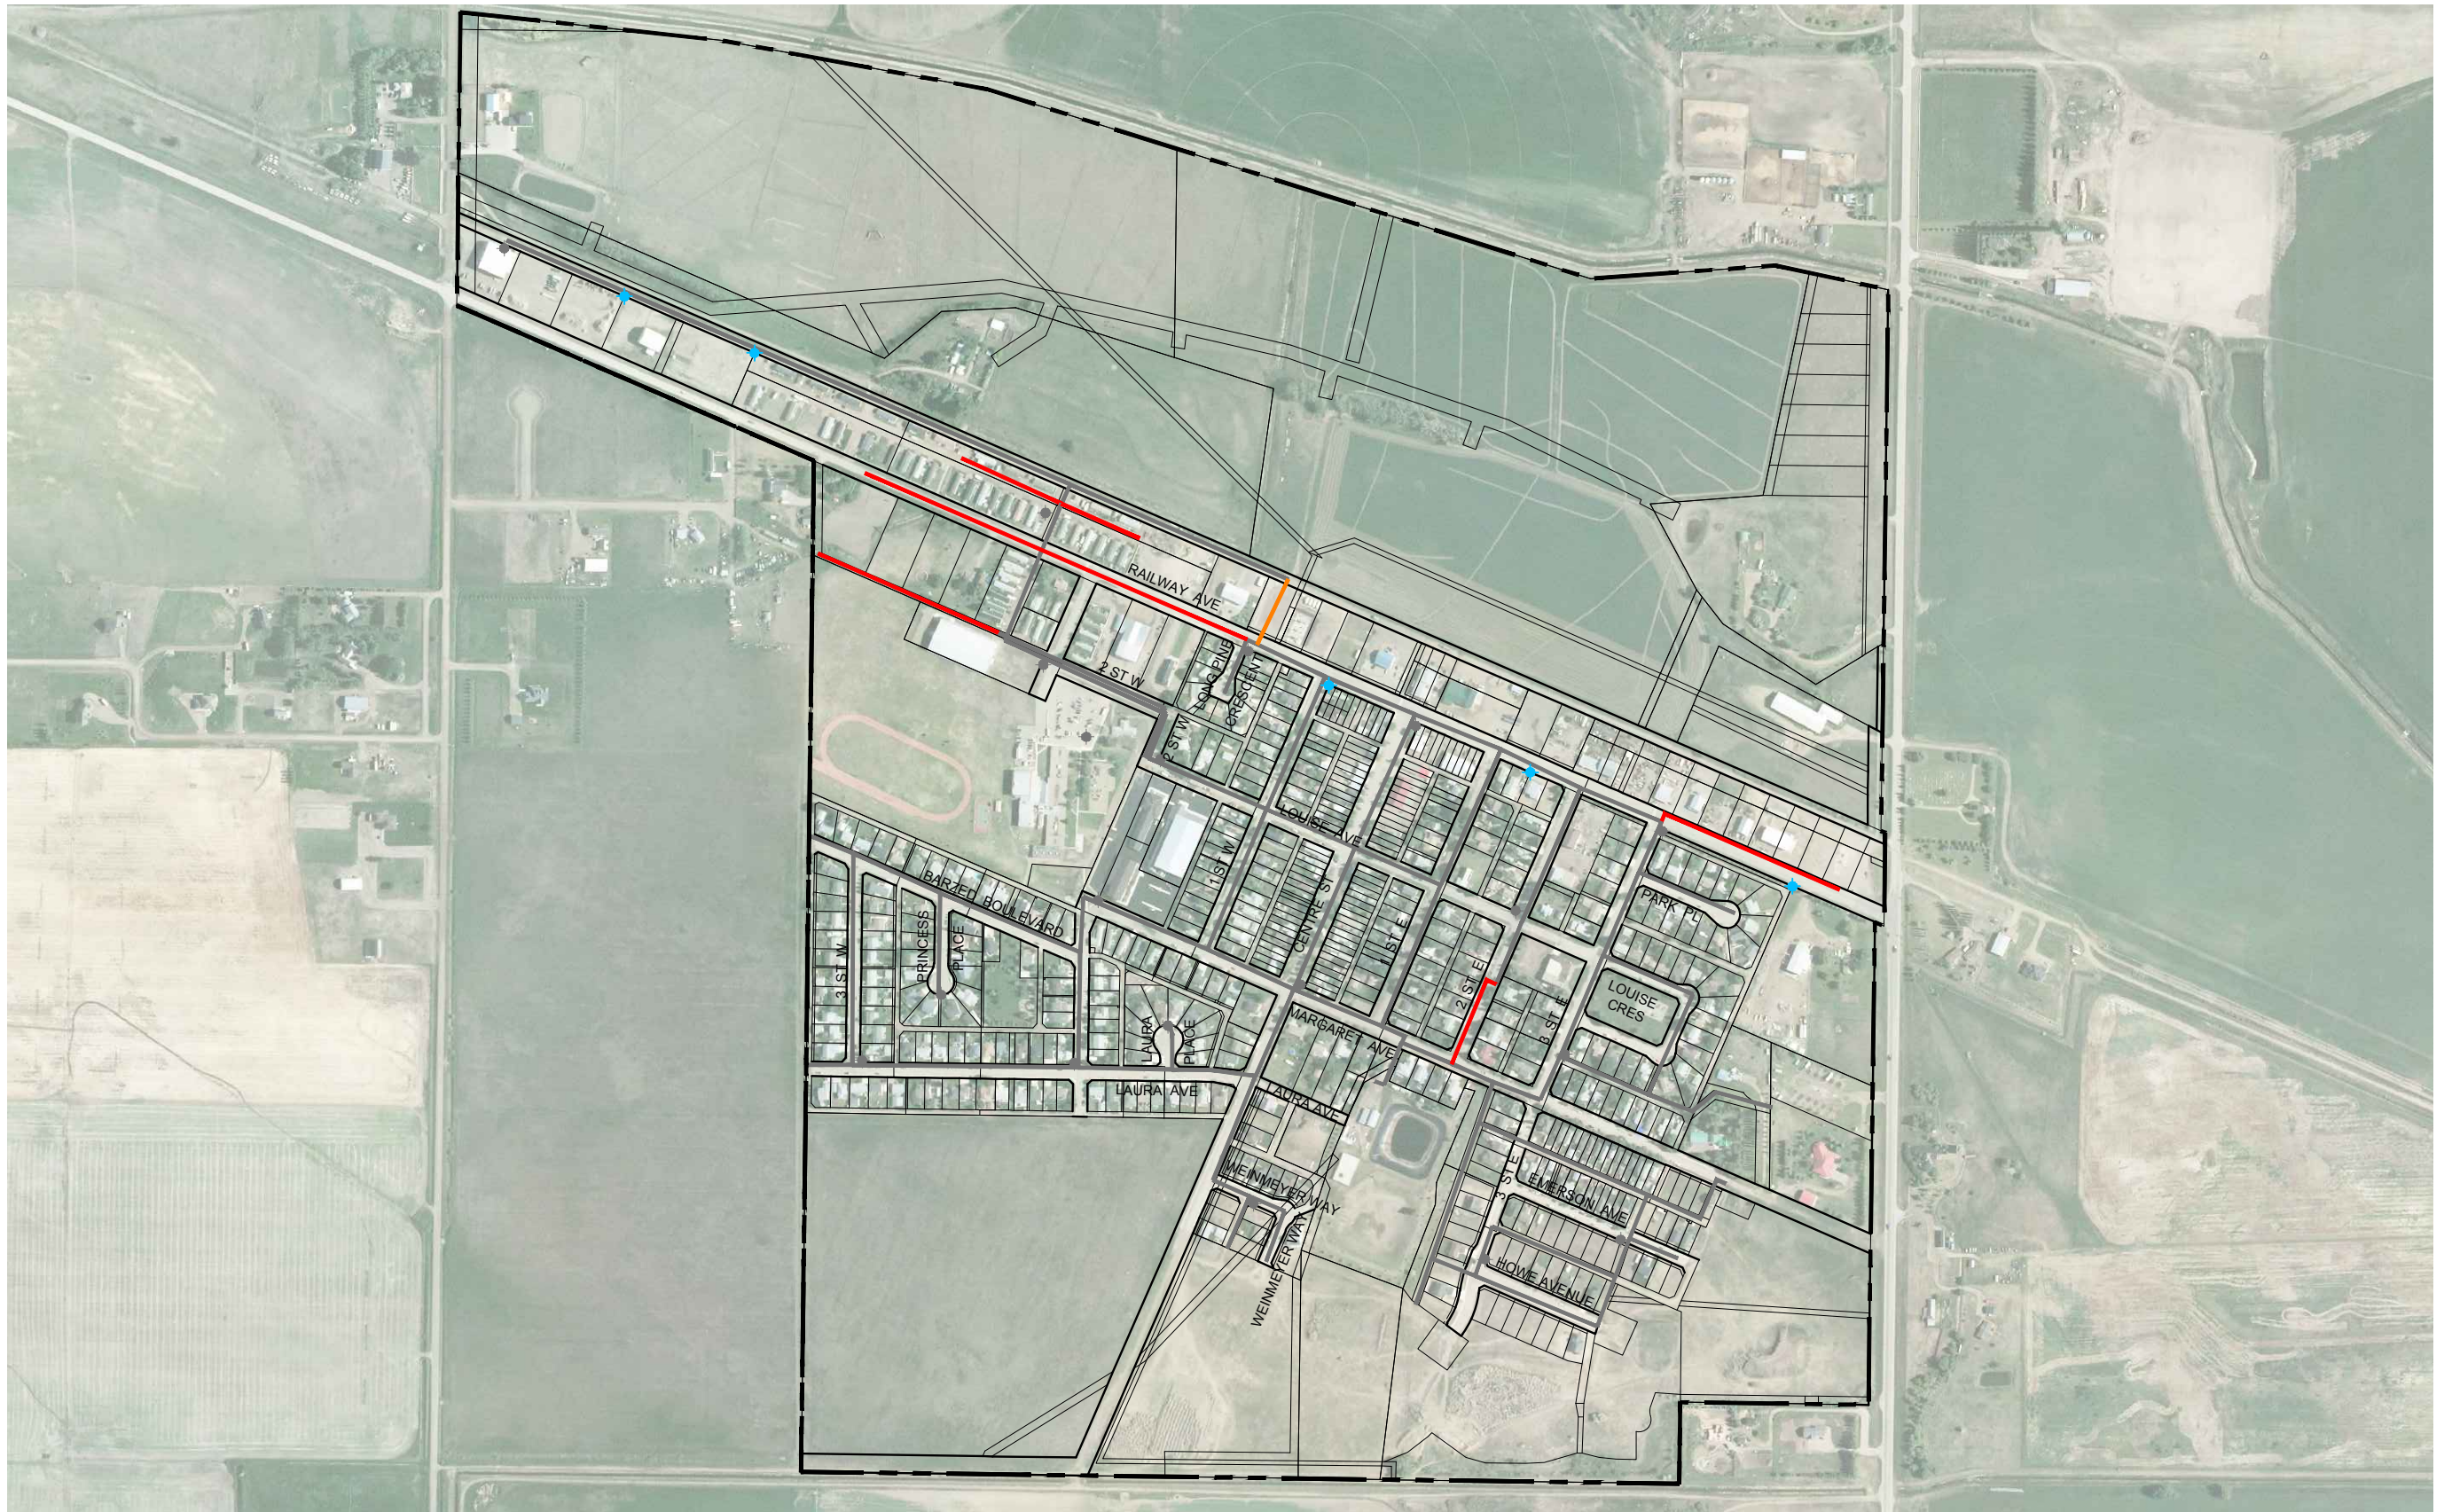
Due to a lack of water main looping and undersized mains, the hydraulic model indicates that the current distribution system does not have the capacity to provide the recommended fire flow (4,000 L/min) in 24% of the Village.

The completion of the loop from Long Pine Crescent to the main on the north side of Railway Avenue will significantly reduce the insufficient fire coverage of the minimum recommended fire flow (4,000 L/min) in the northwest from 24% to 14%.

Major upgrades are required to supply the recommended 11,000 L/min to the school and 7,000 L/min to the commercial/industrial areas northeast of Centre Street.

Fire hydrants should be added along Railway Avenue to decrease the space between hydrants. The FUS recommends a hydrant spacing of 90 m outside of residential areas.

The proposed water distribution system upgrades are shown in Figure 4.2

- To meet current guidelines the systematic replacement of all water mains 100 mm (4 inches) diameter or smaller with 150 mm (6 inch) diameter or greater water mains should be undertaken. This can be completed in conjunction with other infrastructure work and as budgets permit.

- It is recommended that the proposed upgrades be incorporated into the Village's infrastructure improvement plan to be completed in conjunction with other infrastructure works that the Village proposes (i.e. roadwork, sanitary and storm sewer) to ensure an efficient use of funds.
- Maintenance should continue to be a systematic part of the Village's activities to protect its investment in infrastructure. Flushing of water lines and operation of valves and hydrants should continue to be a regular and ongoing activity. Unidirectional flushing is the recommended method as it more effective and efficient than opening a hydrant alone.

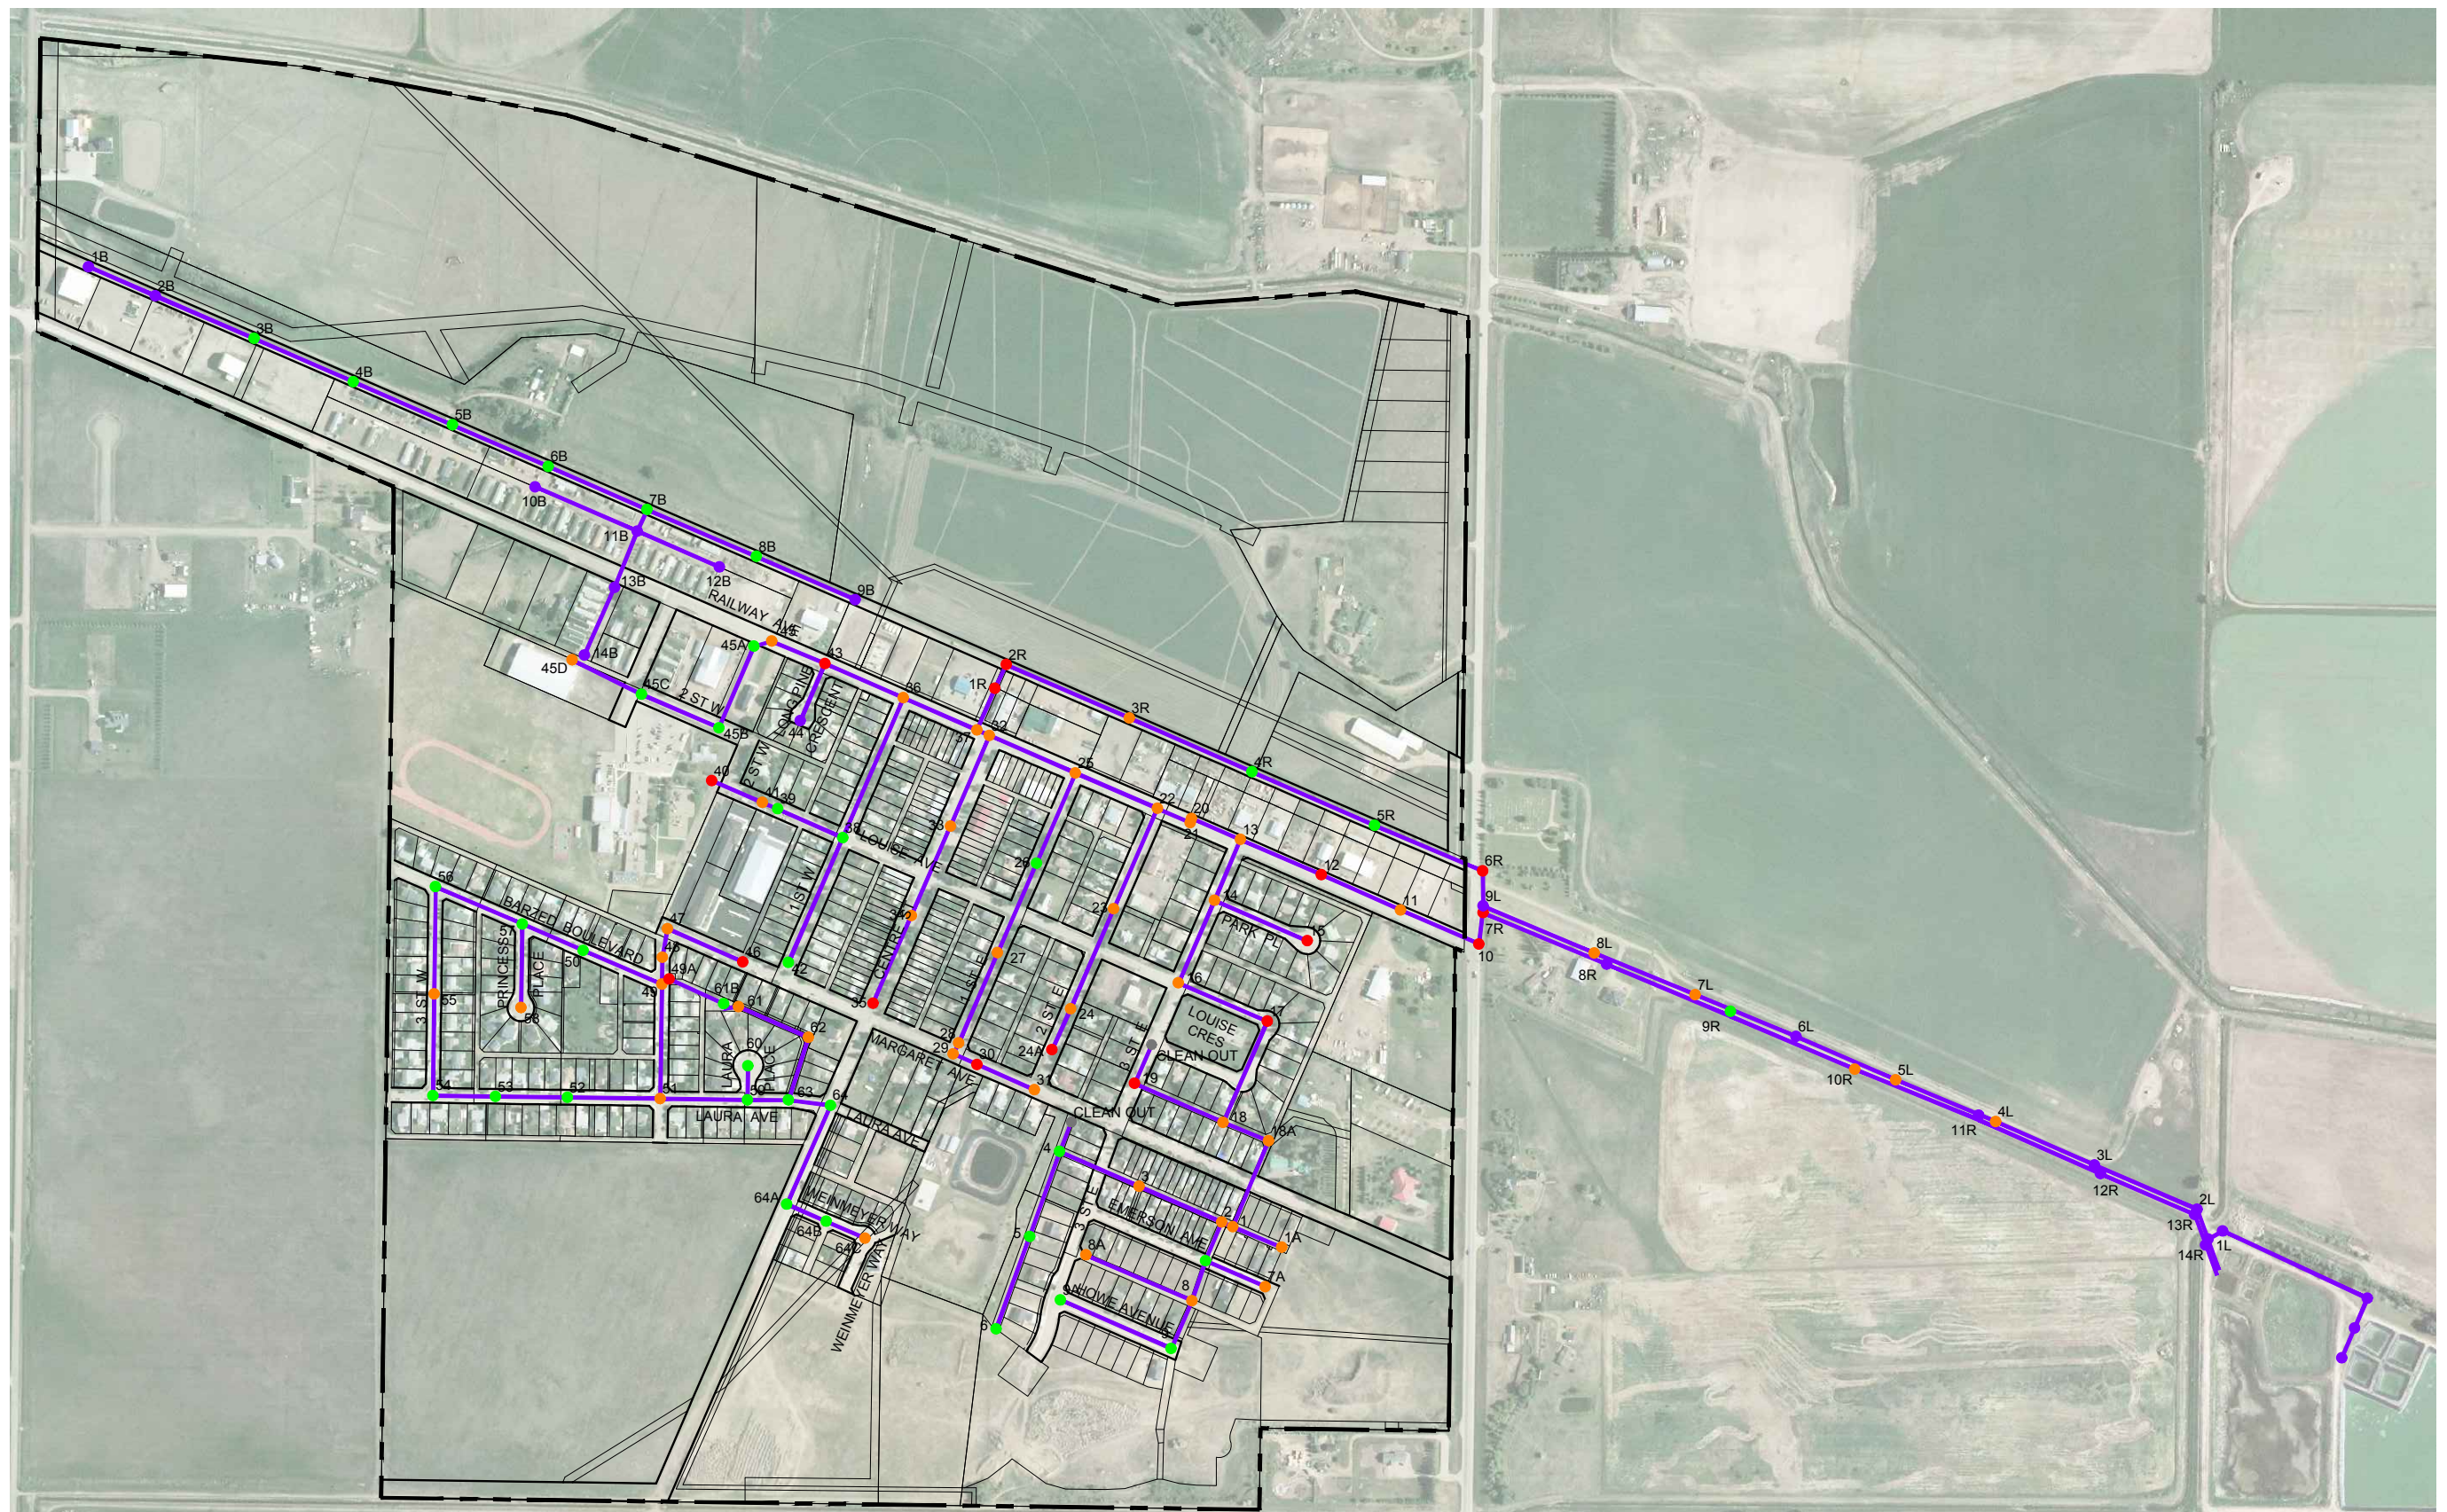
INFRASTRUCTURE MASTER PLAN  
SANITARY COLLECTION SYSTEM  
PIPE AND MANHOLE CONDITION  
EXISTING

The results of the model indicate that the existing Dykstra subdivision lift station has sufficient capacity for the current (2018) and future (2038) average day and peak flows. As no flow monitoring data was available, an assumption was made to follow the City of Lethbridge standard for Inflow/Infiltration of 2,000 Lpcd. This flow was divided evenly over the entire system. The results of the model indicate that the lift station is capable of handling flows at this rate. Discussions with Village personnel indicate that the lift station is not capable of handling the wet weather flows during some larger rain events. This indicates that there are many homes in the area with roof leaders or sump pumps connected to the sanitary collection system. A program to encourage residents to disconnect their pumps from the sanitary system, installing a storm system with storm services to each lot, or upsizing the pumps in the lift station is recommended. The first step would be to install a flow meter in the lift station or an upstream manhole to collect flow data to determine the rate of I/I during the wet weather events to determine proper sizing of upgrades.
