**Village of Duchess**  
**Infrastructure Master Plan**  
(1447-001-01)

October 2018

**Re: Village of Duchess – Infrastructure Master Plan**

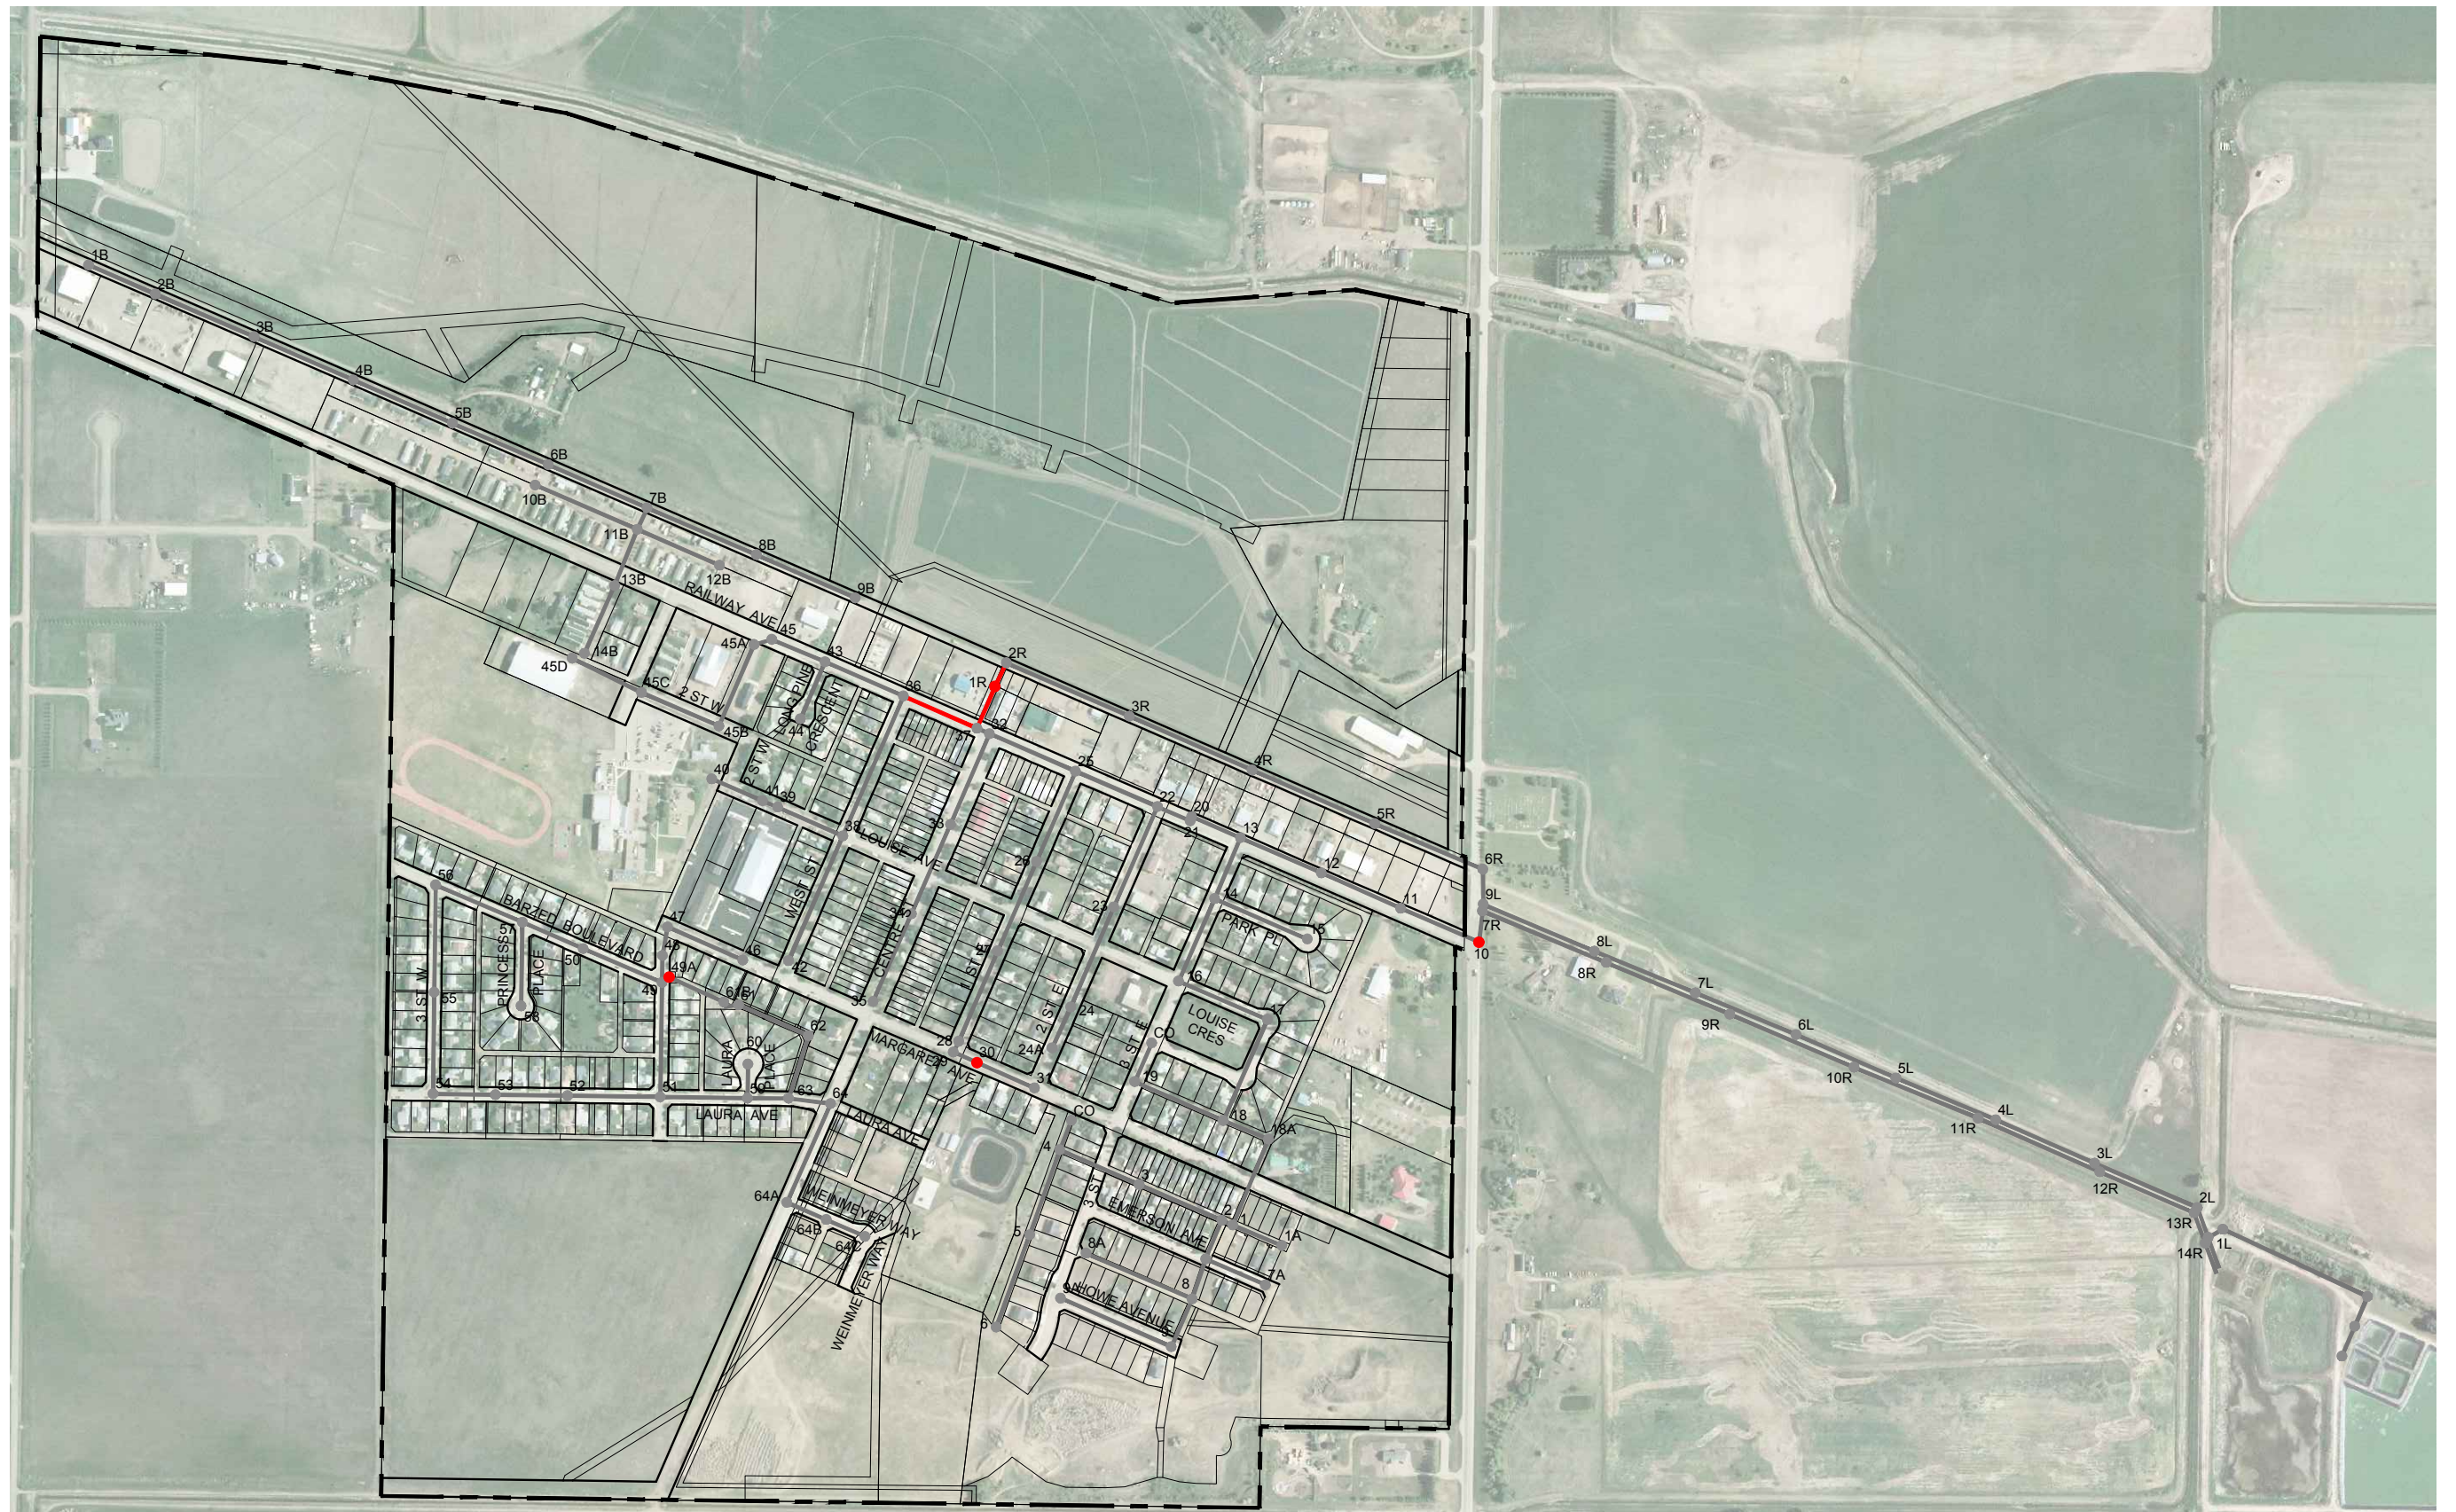
Table 5.2 – Sections of Sanitary Main with Flat Grade				
Start MH	Stop MH	Diameter (mm)	Slope (%)	Recommended Slope (%)
S MH 29	S MH 28	200	-0.15	0.40
S MH 1	S MH 18A	200	0.22	0.40
S MH 1R	S MH 37	200	0.26	0.40
S MH 6B	S MH 7B	200	0.32	0.40
S MH 53	S MH 52	200	0.32	0.40
S MH 59	S MH 51	200	0.33	0.40
S MH 4	S MH 3	200	0.33	0.40
S MH 8B	S MH 7B	200	0.34	0.40
S MH 6L	S MH 5L	250	0.18	0.28
S MH 8L	S MH 7L	250	0.20	0.28

The proposed upgrades to the existing system are outlined in Figure 5.3.

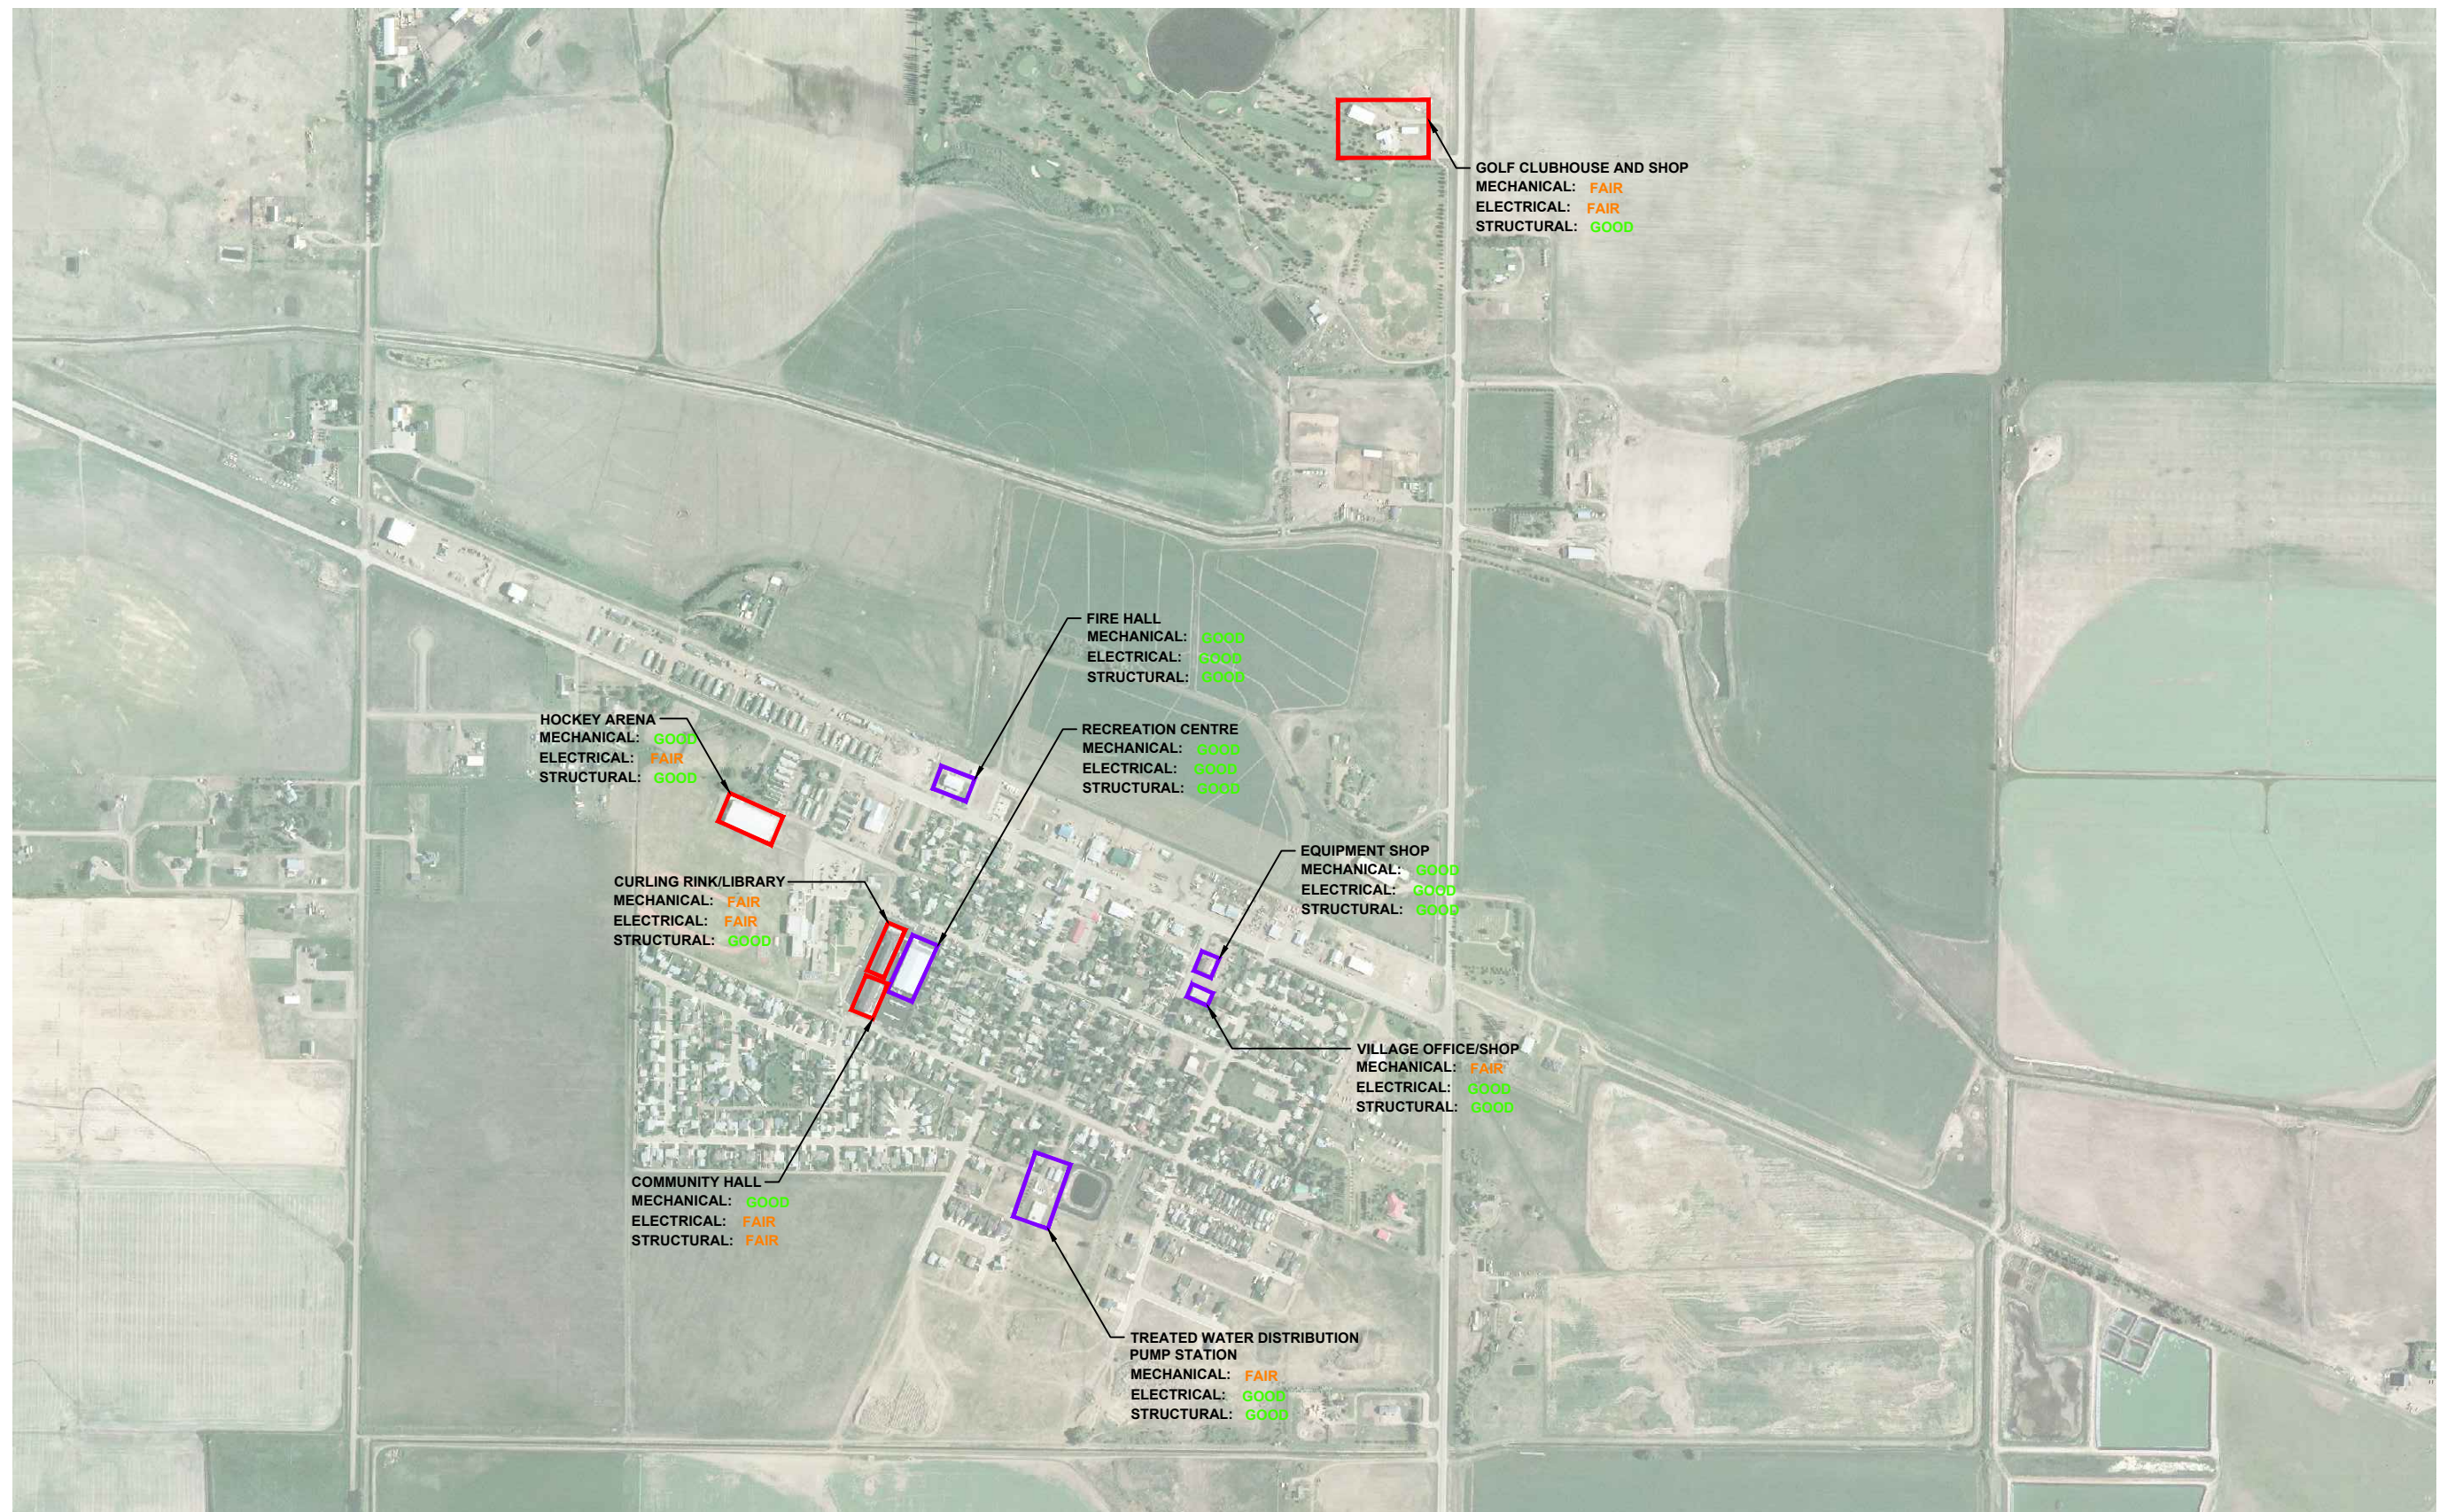
VILLAGE OF DUCHESS  
INFRASTRUCTURE MASTER PLAN  
BUILDING CONDITION ASSESSMENT

with exposed framing. Some cracks are visible in the gyproc joints in the ceiling and should be repaired (\$1,500).

- The clubhouse is single floor, wood framed, built in 1992. The building is vinyl sided with a shingled roof. It has an approximated area of 3000 ft<sup>2</sup>.
- There are no visible cracks in the foundation.
- The doors and windows are in satisfactory condition.
- The interior consists of a combination of floor tile and carpet, and finished gyproc walls.
- The kitchen floor is vinyl tile and in good condition.
- The cabinets in the kitchen are in acceptable condition. The counters are worn and should be refinished in 5 years at the latest (\$2,500).
- The asphalt and landscaped area surrounding the clubhouse provides adequate drainage.
