**Village of Duchess**  
**Infrastructure Master Plan**  
(1447-001-01)

October 2018

**Re: Village of Duchess – Infrastructure Master Plan**

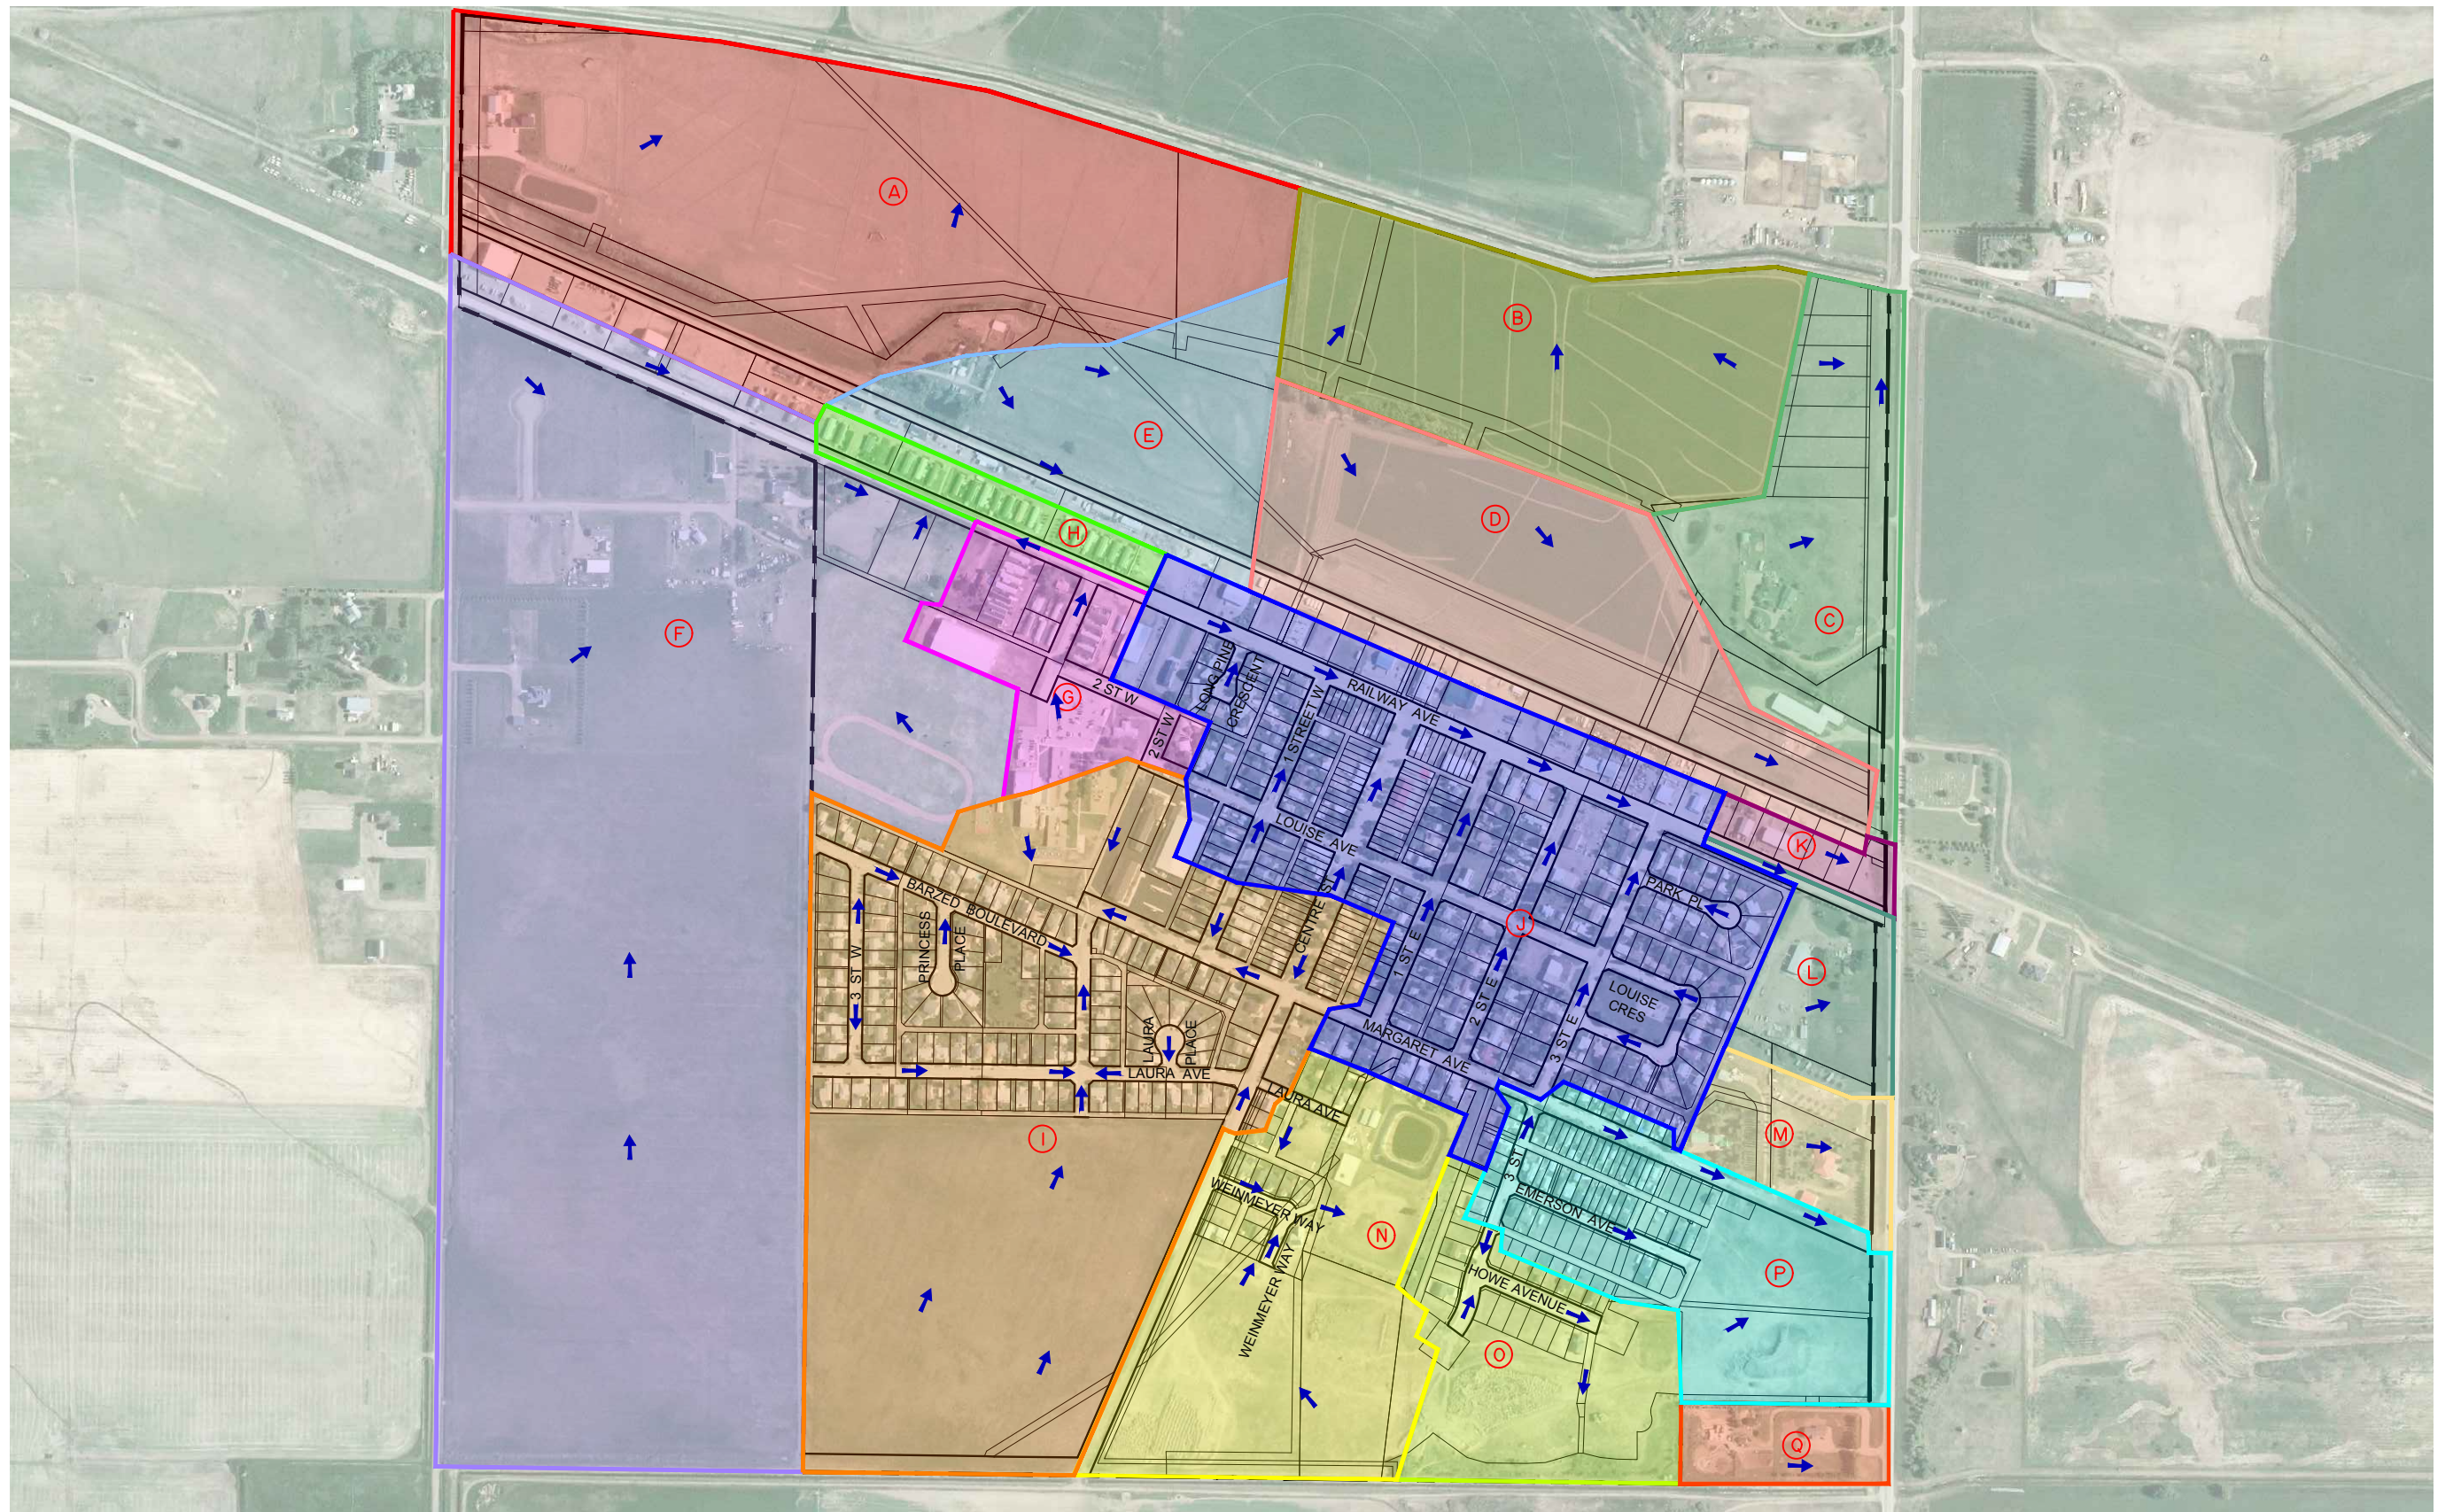
FIGURE: 6.1

The study area is divided into 17 main catchment areas as shown on Figure 6.1. Catchments A and B encompass the north and north west sections of the Village and drain north to the Eastern Irrigation District (E.I.D.) canal. This area is largely undeveloped with the storm water runoff draining by overland flow.

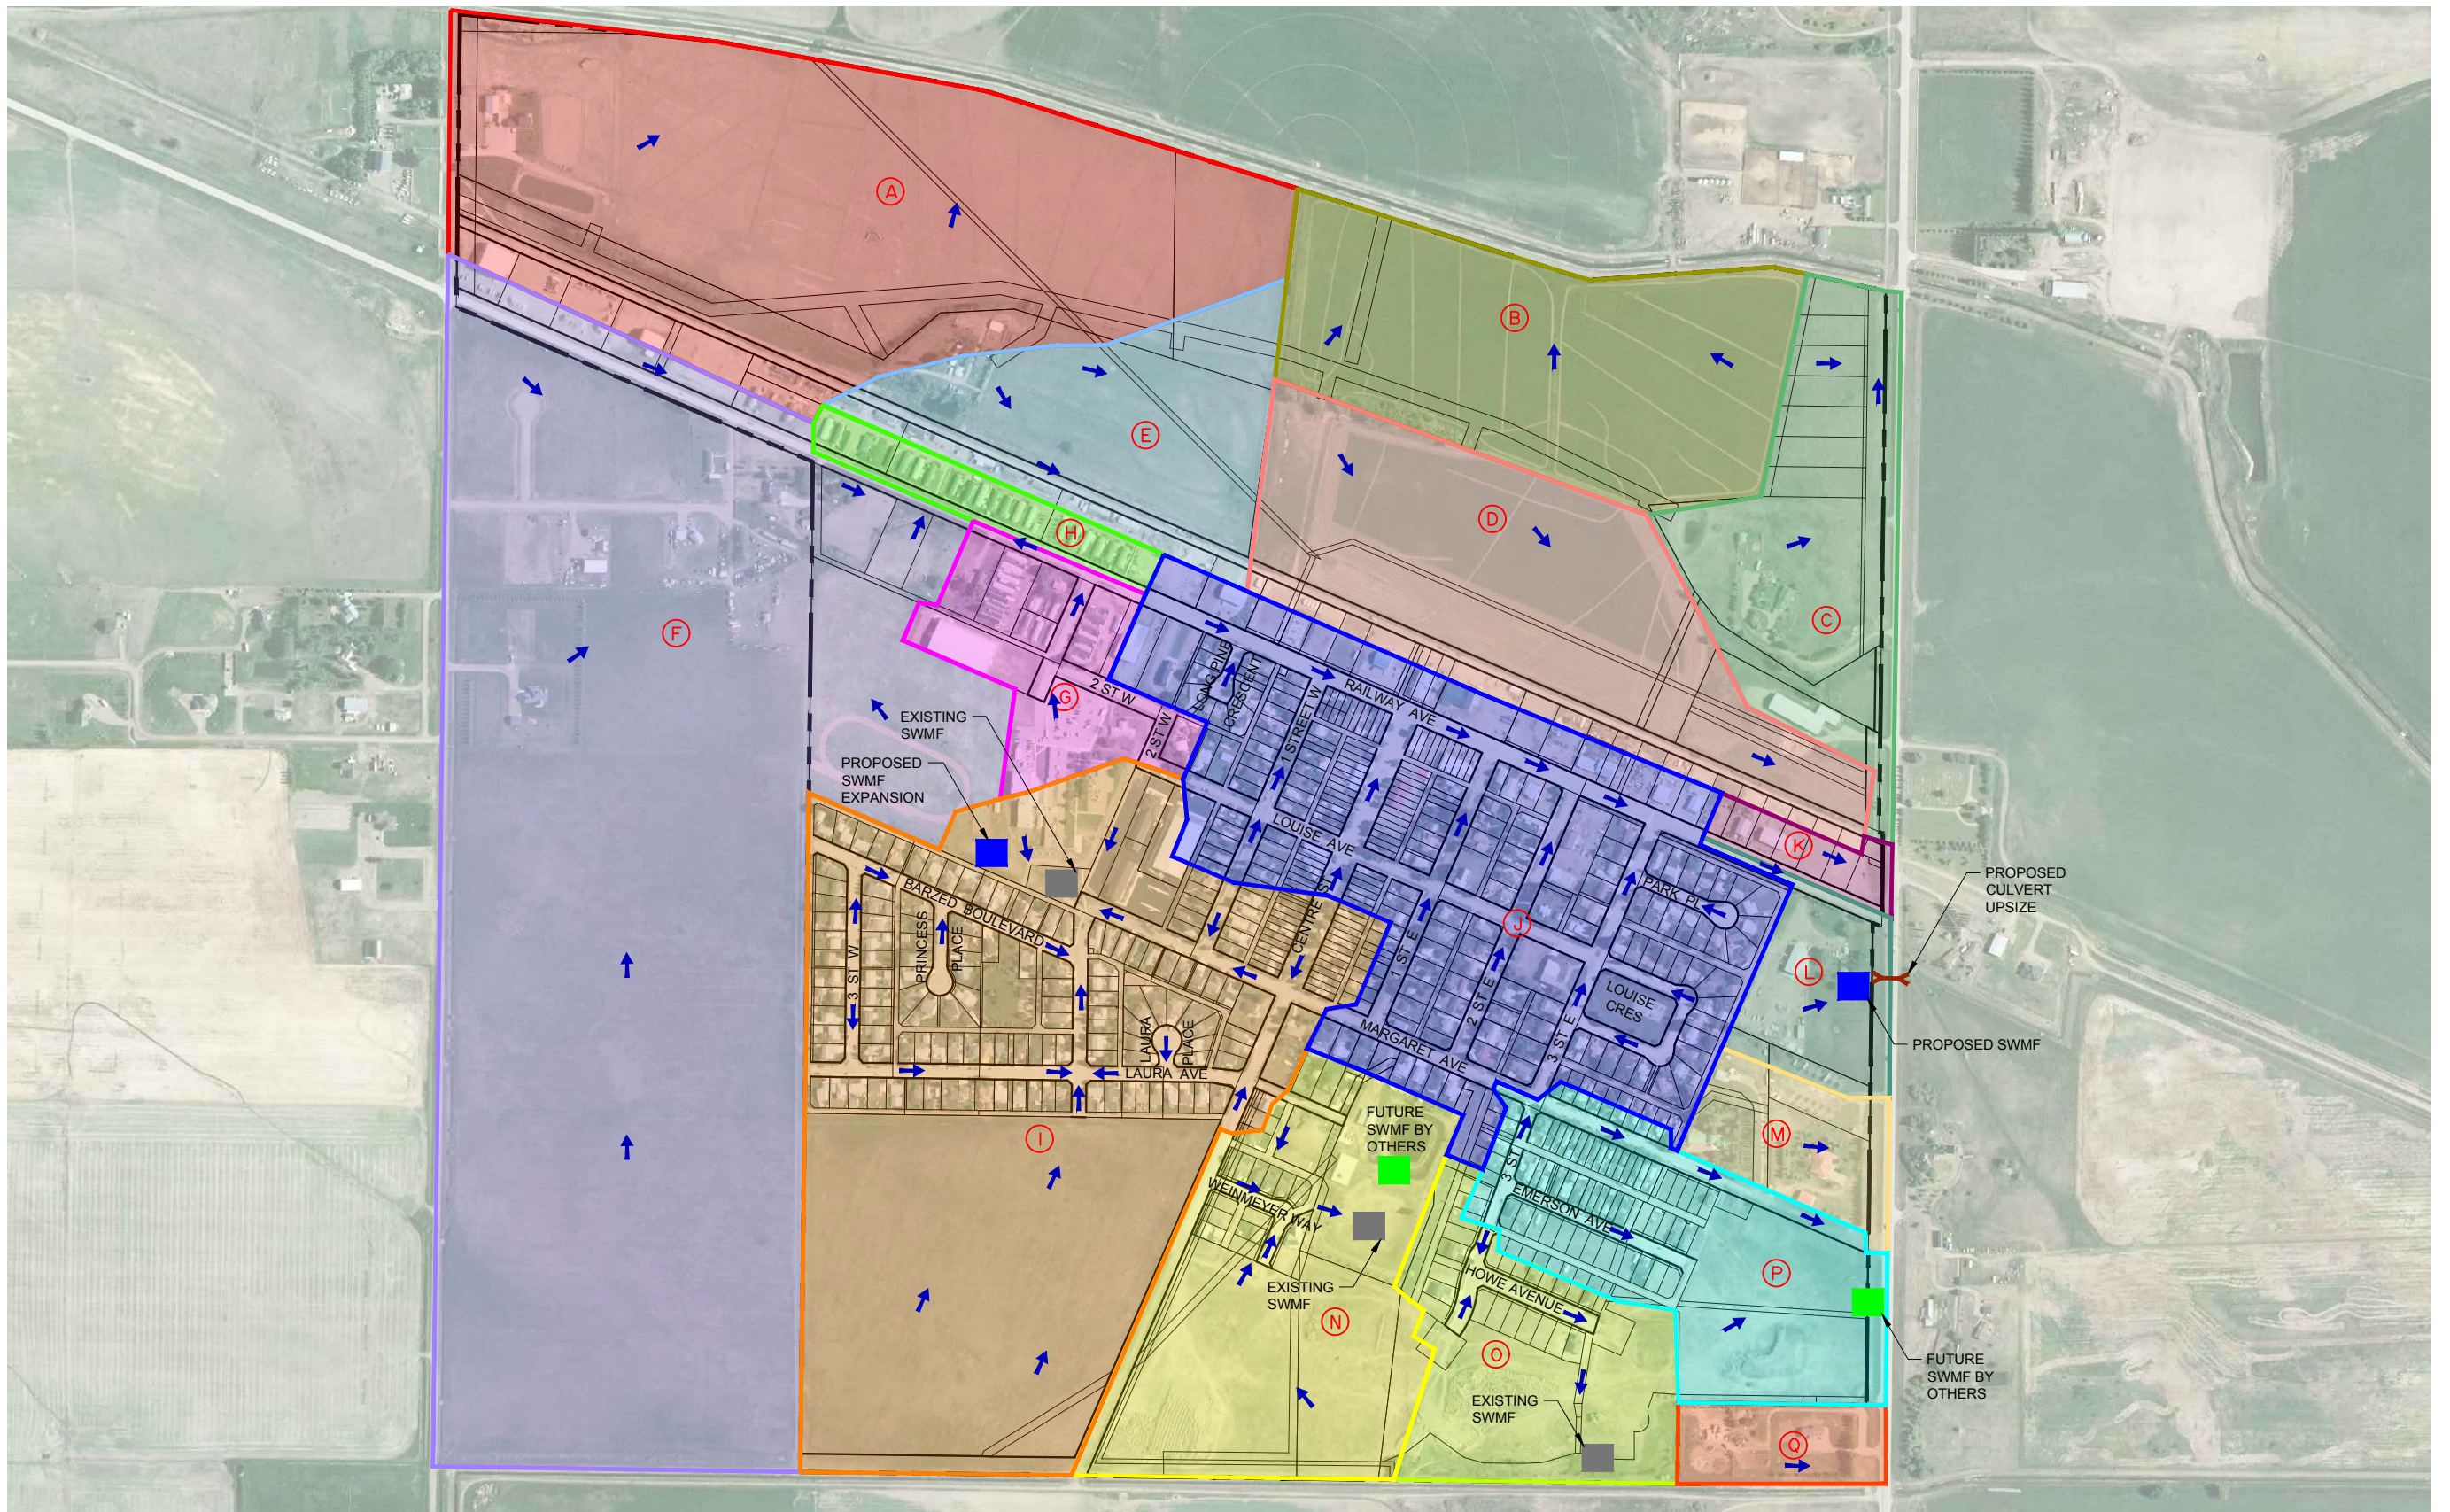
EXISTING STORM WATER  
MANAGEMENT FACILITY

The site survey and the computer modeling results show that there will be ponding at the storm water collection system outlet at Railway Avenue and Highway 873. This is because the outlet is lower than the culvert that crosses Highway 873. To eliminate the ponding resulting from a storm event the culvert that crosses Highway 873 should be lowered and upsized as discussed in 6.4.1.
